Practical experience and test concepts

Application of large profiled plastic pipes

Source: Bosseler, Sokoll, Falter, Holthoff: bi UmweltBau 5/2006

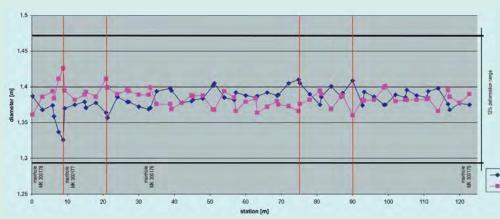
Figure 6: Horizontal and vertical diameter values compared to the permissible deformation range (long-term, DR = 2 x δ_{v}), example

- 2. The measuring data is processed and is recorded graphically (cf. Figure 6). Here, the horizontally and vertically measured diameter values are plotted on the y-axis; the stations are to be taken from the x-axis.

- 3. A permissible deformation range (DR) is chosen, e.g. from the regulations in [12] or from the static calculation ($DR = 2 \times permissible$ δ_{ν}), and is inserted into the diagram by means of two horizontal lines. Since the actual diameter of the undeformed pipe does not have to correspond to the target diameter according to the manufacturer, the deformation range is oriented at the mean value of all measuring values by especially taking into account extreme deformations (cf. [4]).
