MOERRIOOL

“The great main sewer of Arnhem”

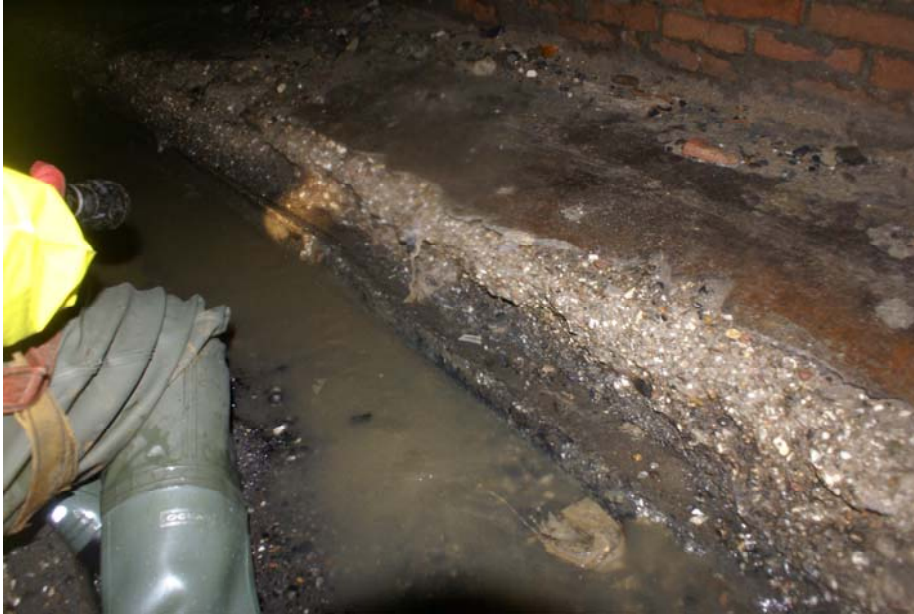
Corrosion damage

Sags with inclination
(bedding material flushed out)

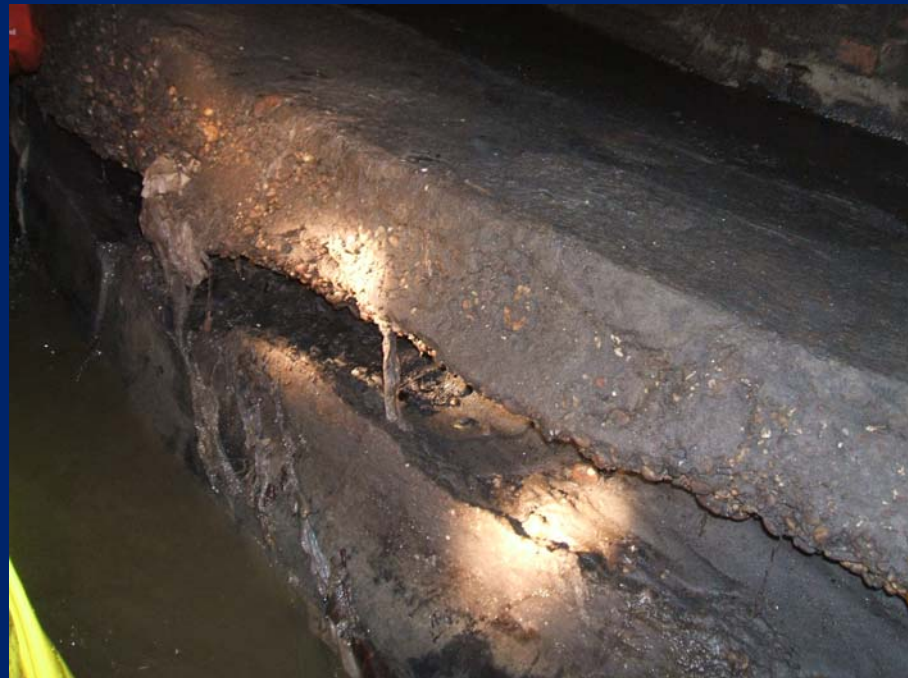
Cracks in the masonry arch

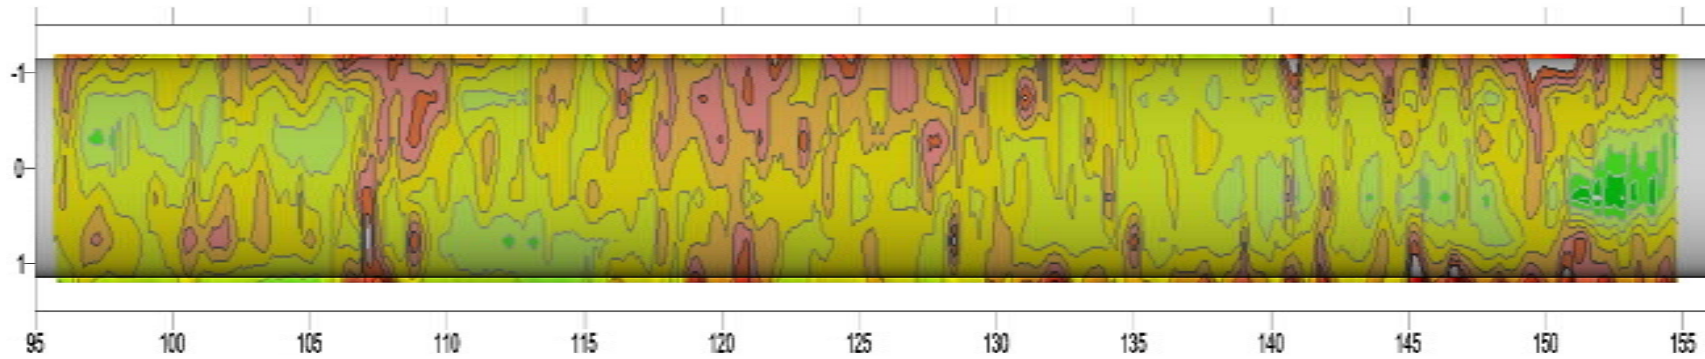
Around masonry arch

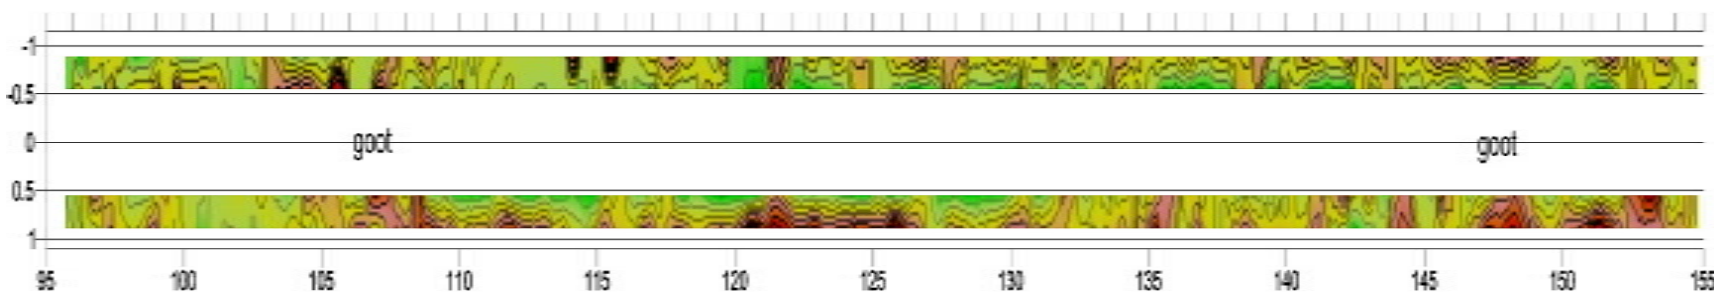
Under Banquets

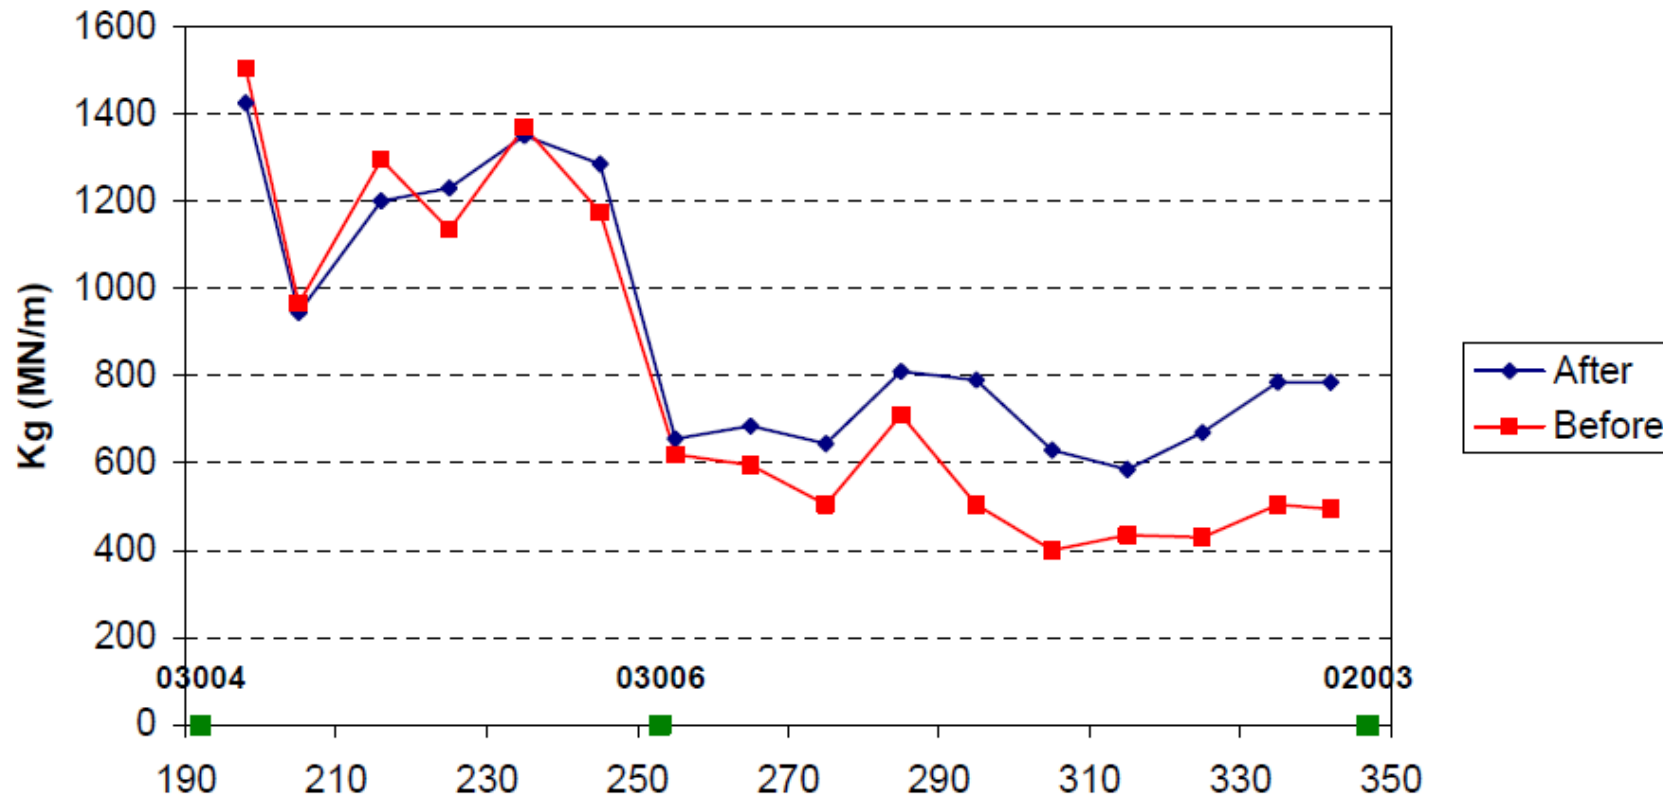
ARNHEM - MOERRIOOL - MAC test
From manhole 03004 to manhole 02003 - 149 mL
Global Stiffness before and after Works (PU injection)

Critical areas between 250 and 350 = +53.2%.
