Competition moves up to the test winner

Reprint of IKT product test „tube liners for lateral pipes“

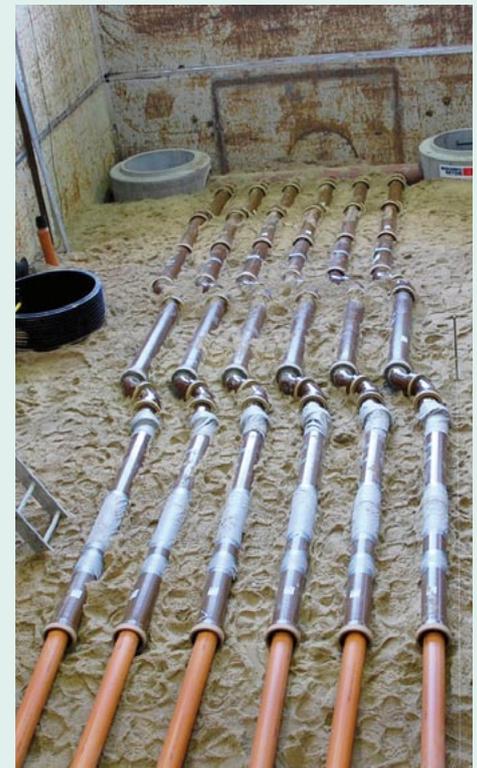
Test lines, extreme situation before covering: different pipe materials and diameter in the IKT large-scale test facility

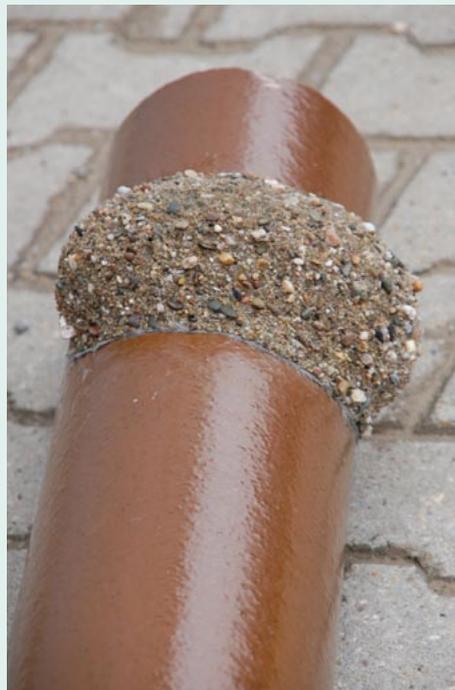
Especially at extensively damaged spots and leaky sockets, considerable quantities of liner resin leaked apparently uncontrolled into the ground. A thinner wall thickness is to be reckoned with at these points. Tightness and load-bearing capacity were characterised by the composite behaviour between liner material, resin leakage as well as old pipe and ground.

Resin leakage at damaged area
