IKT LinerReport 2013

Ten years of the IKT LinerReport

Quality and transparency oblige

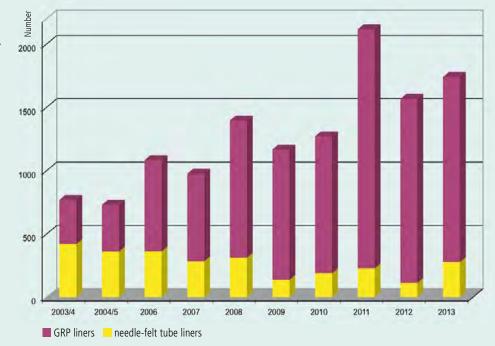
Diagram 1: Number of liner samples IKT-LinerReport 2003 - 2013

The ten previous IKT LinerReports incorporated the test results of a total of just on 13,000 site samples. Of these, 10,000 were taken from GRP liners, and slightly less than 3,000 from needlefelt (NF) liners. The numerical balance between GRP and NF liners had been virtually equal in the first two LinerReports, but the picture changed clearly, in favour of GRP liners, from 2006 onward at the latest (see Diagram 1), reflecting the now greater market importance of this composite material. New suppliers have entered the market in recent years, NF suppliers have added GRP to their ranges, and traditional GRP suppliers have improved their products and launched new versions.

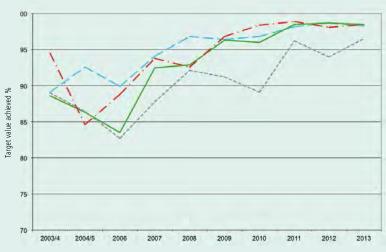
Diagram 2: Test results of all samples

Average "Target value achieved"

The overall picture for the past ten years shows a significant improvement in the test results for modulus of elasticity, flexural tensile strength, wall thickness and water tightness. As late as 2008, the data still fluctuated between an average of 85 percent and 95 percent of tests passed which, conversely, means that there were, on average, problems with tube liners immediately after installation in an average of 15 percent of all cases. The results consistently exceeded the 95 percent boundary on average only from 2009 onward, and are currently tending toward the 98 percent mark. Only in the case of the "wall thickness" criterion are the targets achieved less frequently.

All in all, tube-liner quality manifests a clear upward trend. The results for all four criteria have improved by an average of 10 percentage points in the last ten years.

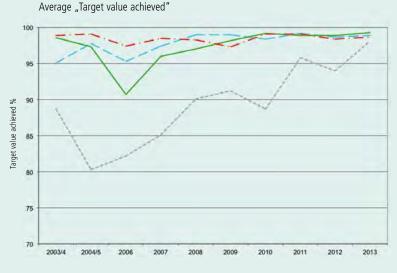
Diagram 3: Test results GRP liners

It is readily apparent, when one examines the test results for GRP and NF liners (see Diagrams 3 and 4) that GRP liners achieve scores of above 95 percent on average almost continuously for the criteria of modulus of elasticity, flexural tensile strength and water tightness (exception: 2006). The results for wall thickness lag significantly behind, however, catching up with the good results for the other three criteria only in 2013. Whether this will be a permanent improvement remains to be seen.

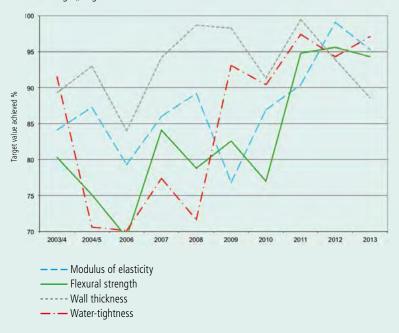
Except in the case of wall thickness, the average test results for the NF liners are generally significantly below those for the GRP liners, on the other hand (see Diagram 4). They also fluctuate significantly from year to year. They consistently cross the 95 percent mark only from 2011 on, catching up with the GRP liners although, with the exception of water tightness, they drop back again slightly in 2013.

This controversy, which was scarcely comprehensible even for expert insiders, ultimately concluded with a number of producers of needle-felt tube liners applying for amendment of their DIBt approvals. The inner film has since this time been defined as an integral part of the liner and is no longer cut prior to the test. It was, however, necessary to demonstrate in advance the suitability of these films by means of a DIBt test programme. The results of the water-tightness test then improved significantly (from 2009 onward, see Diagram 4).

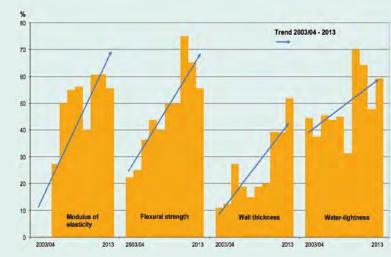
Diagram 5: Refurbishing contractors with 100% success rates

Number of contractors in percent per test criterion

A top group of refurbishing contractors has now formed for each of the four test criteria. The liner samples from these contractors achieve the Target values for at least one test criterion in 100 percent of cases (see Tables 2 to 5). Assessment of performance across time discloses a clear trend: the four 100 percent top groups have become significantly larger since the publication of the first IKT Liner-Report ten years ago. The number of refurbishing contractors included in the four 100 percent top groups was between 0 percent and 22 percent (mechanical criteria) and 44 percent (water tightness) in 2003/2004, whereas more than half of the contractors were included in these groups in 2013 (see Diagram 5). 70 percent of all contractors were already in the top groups for the criteria of flexural tensile strength and water tightness in 2010 and 2011, however.

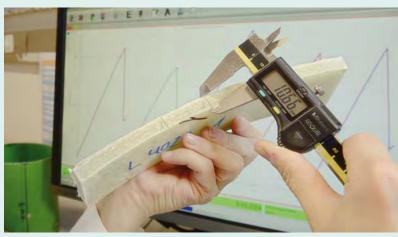
Combined thickness and pure-resin layer are measured using precision slide gauges
