## Manhole Coating: An Alternative Renovation Method?

For the renovation of manholes, coating methods are considered a competitive alternative to the renewal of the manhole. But are they really an alternative? So far there has hardly been evidence regarding limitations of use, influences on quality and the durability of the methods offered. The IKT has lightened the dark: in an extensive practical survey 42 manhole coatings were monitored and investigated at twelve sewage network operators.

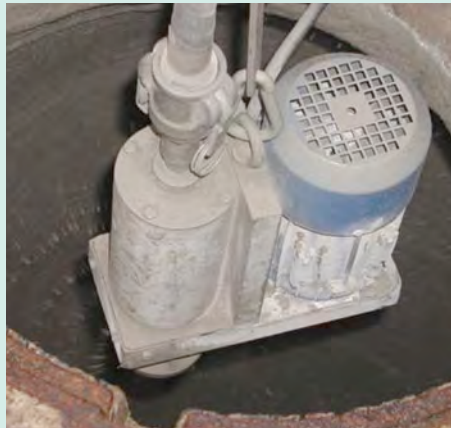
Grout coating in the spray lining process

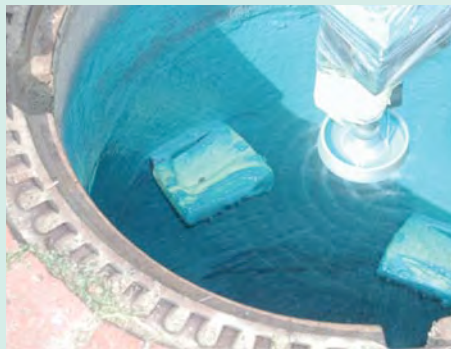
Polyurethane coating in the gunite lining process

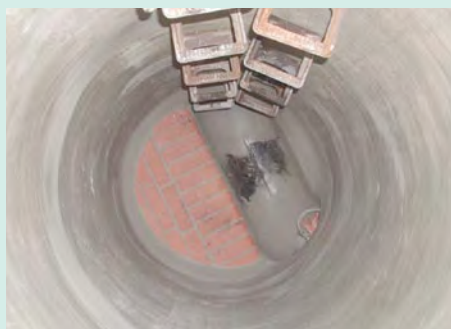
Manhole coated with mortar

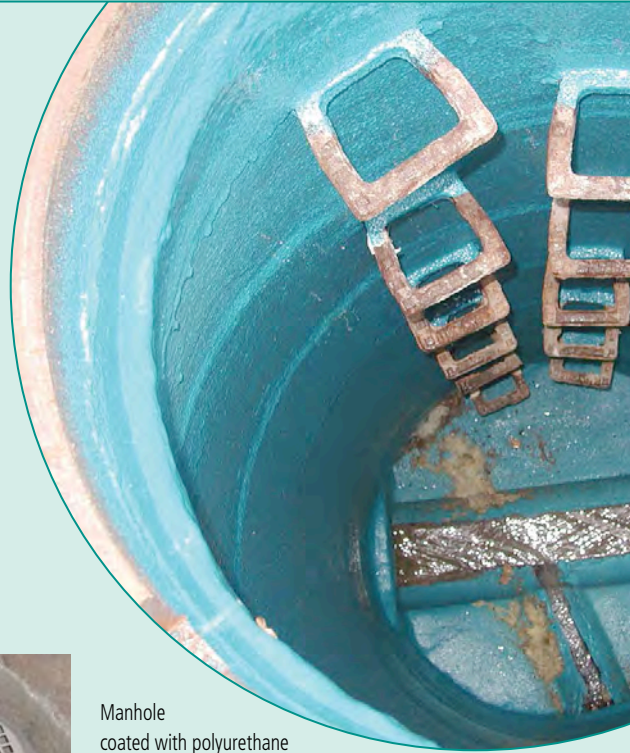
Manhole coated with polyurethane

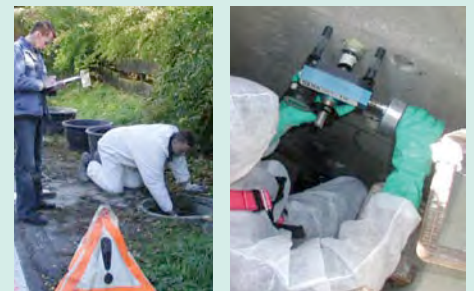
Figure left: Documentation of the conditions on the construction site and the renovation  
Figure right: Quality check of the renovations carried out

42 coating measures in the drainage networks of altogether twelve network operators were monitored. Extensive quality test were carried out over a period of several months. Grout coatings and coatings of polyurethane were used by considering all cleaning- and application methods that are relevant for the market. All renovations were carried out by specialty firms that had only received instructions regarding the coating material and application method. Comments on the renovation procedure were deliberately not made in order to be able to identify the routine working processes, the actual quality of the renovation as well as possible sources of errors and improvement potentials under realistic circumstances.

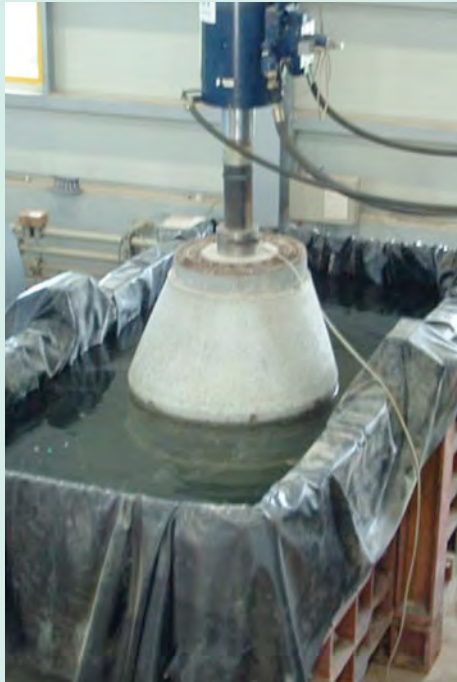
Dynamic load of a coated manhole

To complement these on-site measures, experiments were carried out in the IKT-laboratories and test facilities. In this way, for instance, the effects of intensive traffic loads on a coated manhole could be simulated or the bonding behaviour of coatings on water-saturated concrete surfaces could be investigated further.

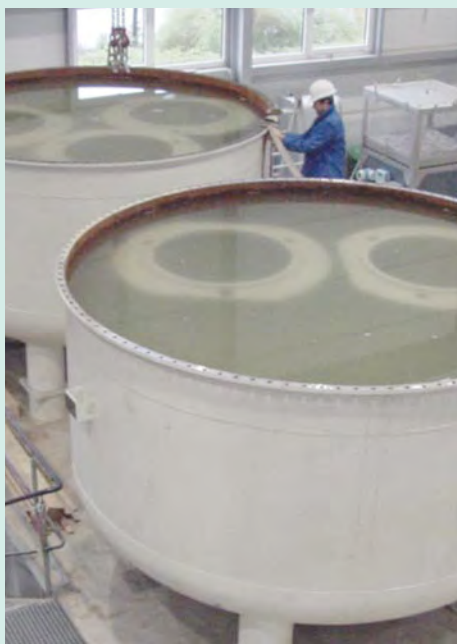
Water saturation of manhole elements

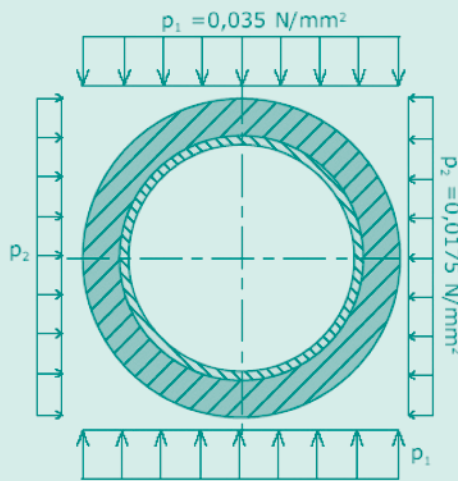
Load case for the numeric calculations of the minimum adhesion tensile strength

building, as well as the importance of adhesion tensile tests are to be questioned. Numeric analyses showed that adhesive tensile stresses in grout coatings, developing under these conditions in a manhole, are below the requirements of the essential guidelines.

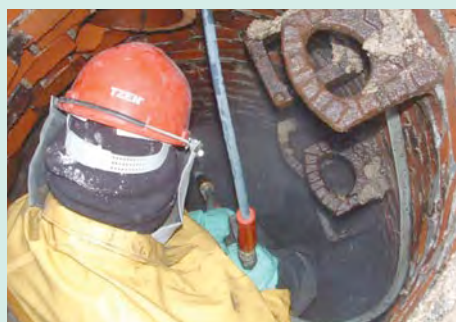
Investigation of alternative pre-treatment techniques

As a test some manholes were cleaned with high water pressure by mixing in sand. The results of the cleaning were clearly better. However, the working conditions for the executive technician were catastrophic: not only was he forced to protect himself against the rebound of water, but in addition against the rebound of sand.

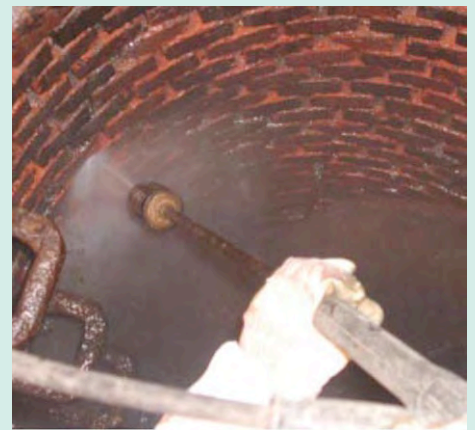
High-pressure water cleaning of a manhole wall with a hand lance

To keep a sustainable subsurface and the pre-conditions for a good bond of the coating, first of all dirt, coverings and glaze as well as damaged material have to be removed from the manhole wall. For this purpose, usually high-pressure water cleaning is used.

In the IKT experiments showed that this method is only scarcely suitable: often coverings and glazes could not be removed from bricks. Also cleaning out brickwork joints in an adequate depth nearly always proved to be difficult. In concrete manholes there is often the problem that the subsurface cannot be roughened adequately to ensure a sufficient hold of the coating grout with the surface.

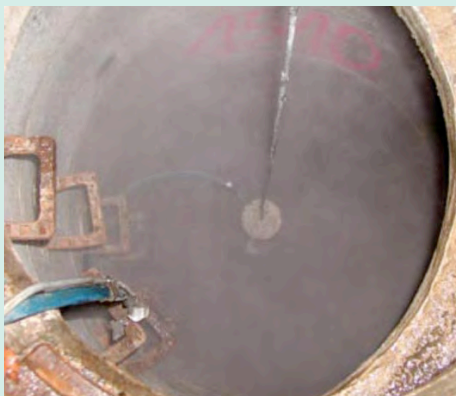
High-pressure water cleaning of a manhole wall with a rotating cleaning nozzle

⚠ Here the industry seems to be in demand: a new cleaning device, similar to the already available rotating cleaning nozzle, is needed in order to apply water and sand mechanically to the manhole wall.

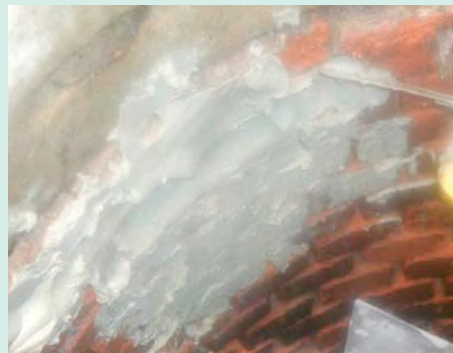
Pre-coating of a brick-built wall with severe joint corrosion

Brick-built manholes with strong joint corrosion and concrete manholes with advanced concrete corrosion have a very uneven wall surface. Before these manholes can be coated by spray lining, the surface needs to be flattened manually with a pre-coating of mineral mortar first.

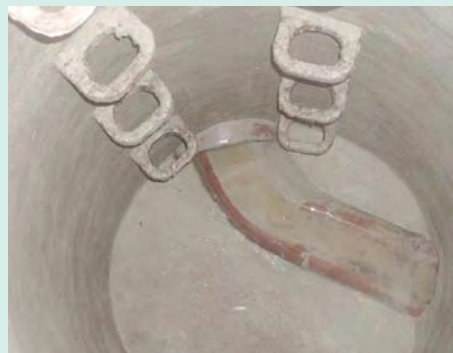
Completely pre-coated brick-built manhole

These manual works often comprise a major part of the total work effort. This pre-coating also presents – depending on the layer thickness – a complete coating of the manhole. By the subsequent mechanical application of a main coating, the compound strength of the pre-coating cannot be increased any further.

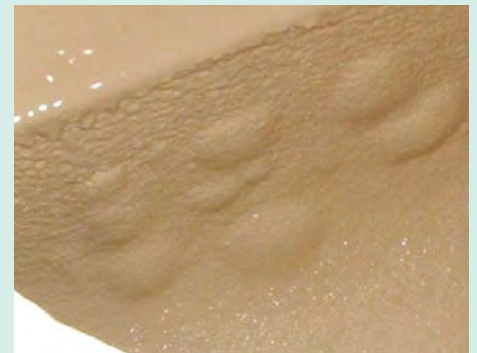
Bubbles in a polyurethane coating with high surface moisture

The laboratory experiments clearly show big differences between the single products offered on the market. Especially the sensitivity towards moisture differs: while one of the PU-products analysed reacted to a high level of moisture, another PU-product showed no visually noticeable reactions.

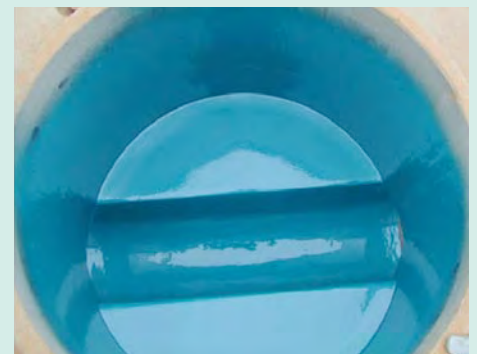
Flawless polyurethane coating also with a high surface moisture level

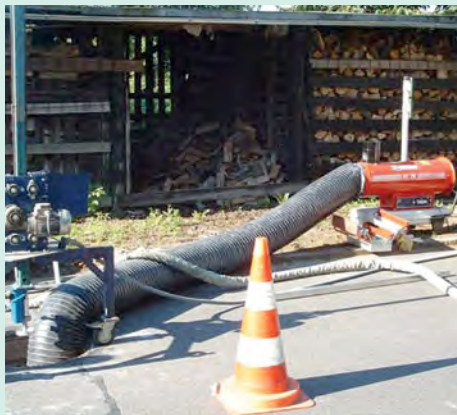
Drying of a manhole in the run-up to a polyurethane coating

Often renovation contractors use mobile heating equipment to dry the brickwork before it is coated. But even after drying, in some cases the surface moisture was still too high.

Thus, our recommendation: wait with the polyurethane coating until the mineral pre-coating has enough residual moisture. Do not use mobile heating equipment for drying.

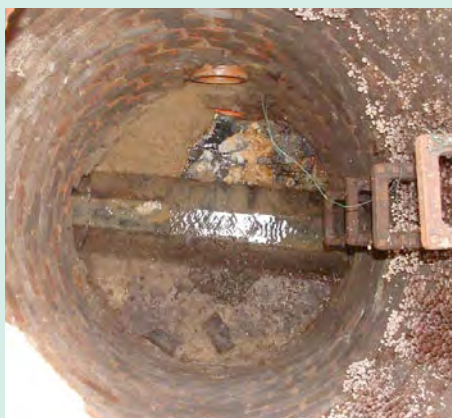
Damaged manhole

In the phase of preparing the renovation the manhole to be renovated should be visually inspected in detail. Ideally, the inspection should be carried out with a high level of groundwater in order to be able to notice leakage in the manhole body.

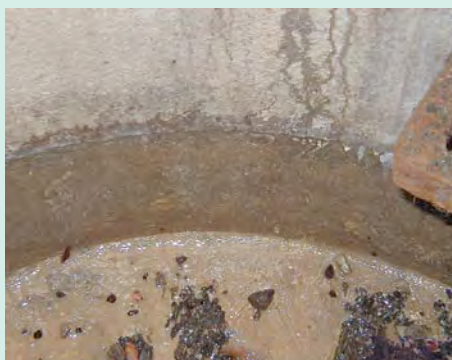
Leaking annular joint inside a manhole of concrete components

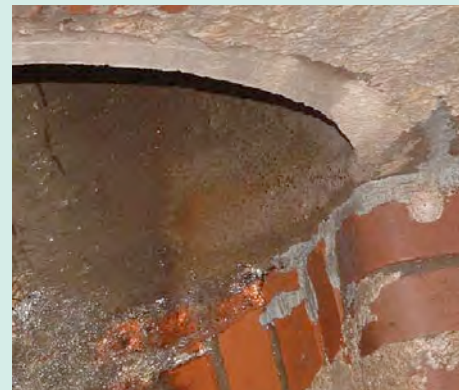
Leakage in the channel in the area of the discharge

Nearly all manholes showed severe damage in the lower area of the manhole body, in many cases the berms, channels and connections to the outgoing sewers also needed renovation.

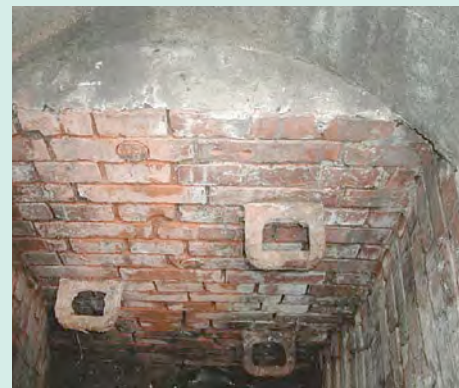
Transition area of a rectangular brick-built manhole/round concrete cone with horizontal ledges in the manhole wall.

If branches were integrated in the wall, they were leaking or damaged in nearly all cases. In the transition area of brickwork to concrete often leakage and transverse displacement were found, which can complicate a renovation with the coating method.

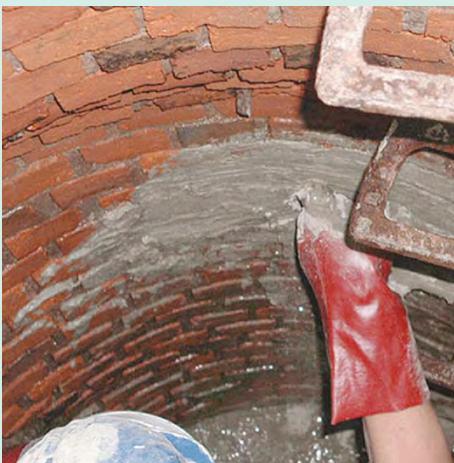
Sealing of a brick-built manhole with filling jointing grout

Before coating, in many cases the manhole wall needs to be sealed. In manholes of pre-fabricated concrete components good results can be achieved with injections like polyurethane resins, for example. Sealing by means of injection in brick-built manholes is more laborious. If there is no in-situ groundwater that pushes, here especially quickly setting repair grout is helpful.

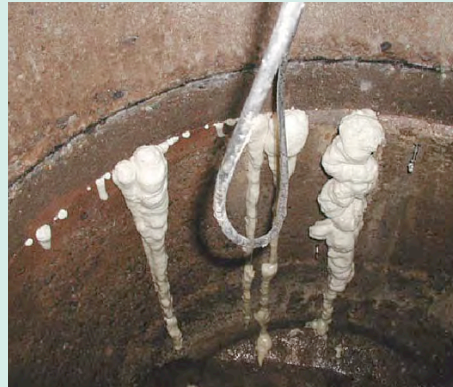
Injection material entering through leaks inside an annular joint of a concrete manhole

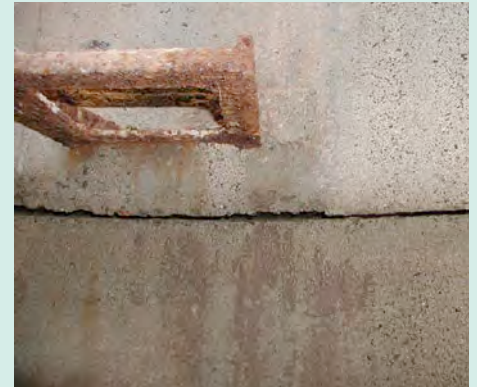
Dirt residues on the wall after cleaning

In practice, insufficient preparatory cleaning can occur. This is why after completed cleaning dirt residues can be found on parts of the wall. A finishing check of the manhole wall before applying the coating is not carried out in all cases.

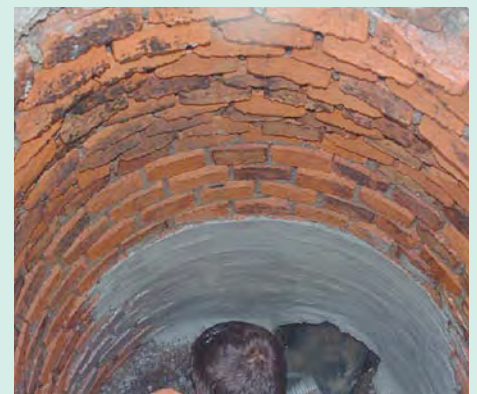
Applying the grout onto a „dirty“ wall

Thus, before applying the coating, a detailed inspection of the cleaned manhole wall should be carried out to be able to notice dirt residues, coverings or a too low material removal and to introduce further measures if necessary.

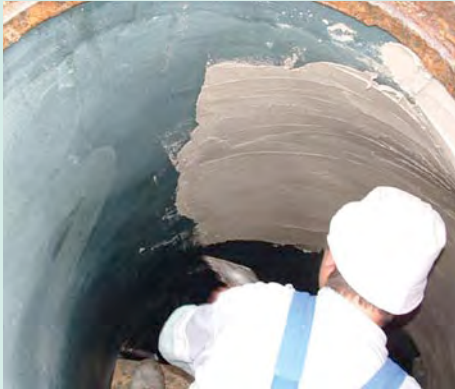
Green-black colouring of the pre-coating inside a manhole with strong impact of sulphuric acid

In many cases inadequate materials, especially for pre-coating, are used. For example, for concrete manholes with severe corrosion only grout products are suitable, which were developed especially for the use in very aggressive sewage.

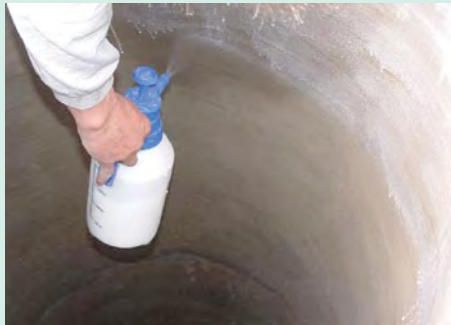
A finishing treatment medium can be of great help

the mortar coating directly after the renovation works, it seems to be possible to prevent too quick drying of the mortar. Sealing the manhole cover with an awning to prevent incoming air does not seem to cause great advantages as a single measure. For polyurethane coatings comprehensive finishing treatment does not seem to be necessary. Here it is advisable, however, to inspect the entire coating cover visually in detail after applying the coating. So imperfections in the coating can be registered and can be removed immediately.

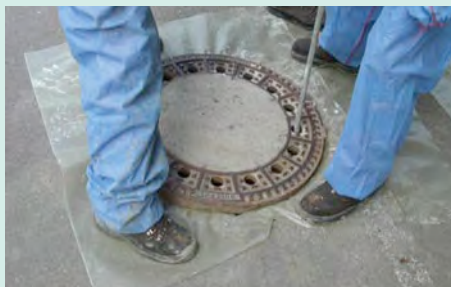
Sealing the manhole cover simply does not suffice

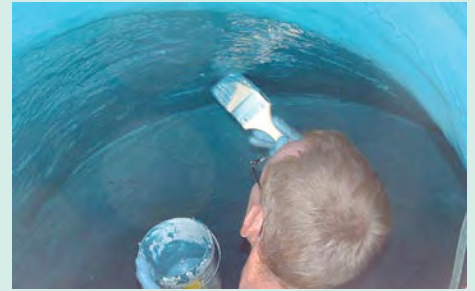
finishing treatment of a polyurethane coating

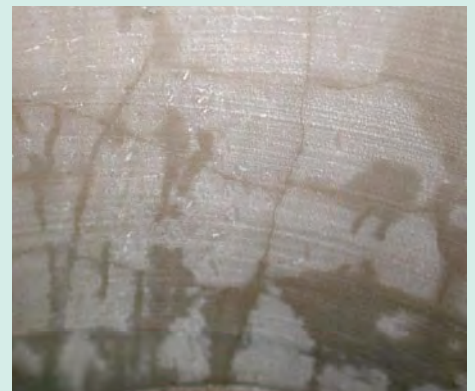
Cracks often become obvious after a couple of months

Weaknesses in the polyurethane coatings normally showed directly after applying the coating or at the latest after an ascent of the groundwater level. In many grout coatings numerous deficiencies could only be observed during an inspection several months after the coating measure. This might be due to the fact that the tensions in grout coatings, which are responsible for the formation of cracks or debonding of the coating, only develop after a few days or weeks from a mathematical point of view.

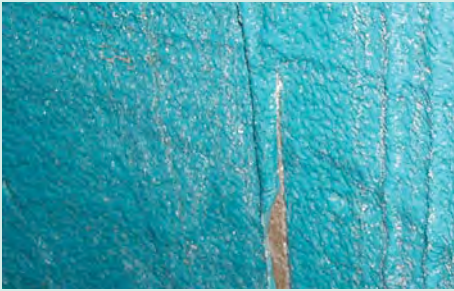
Areas with bad bonding can be noticed after an ascend of groundwater at the latest

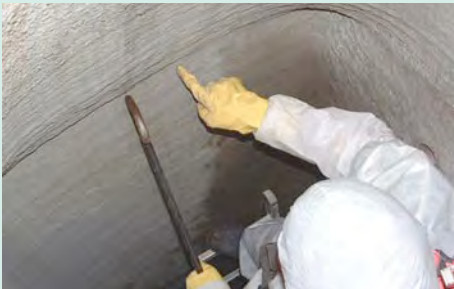
A detailed visual inspection is great help when assessing the quality of a coating

A detailed visual inspection under high groundwater levels including tapping the coating is particularly suitable for an acceptance of manhole coating measures. Lacks in quality such as cracks and leaks can usually be noticed rather well: due to the typical sound when tapping the coating also hollow spots behind the coating can be registered.

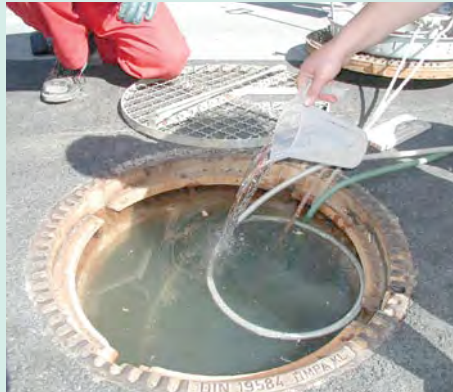
A leaktightness test of a manhole does often not suffice to assess the quality of a coating measure

Often the test results cannot be used due to circular seepage in the area of sealing bubbles, for instance. The costs are often out of all proportions to the usage. In extreme cases (e.g. strong volume stream, large cross sections, corroded sewers) the costs for the final leaktightness test can exceed the costs of the actual renovation measure.

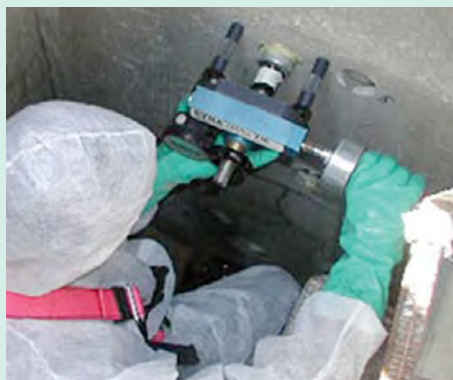
Mortar: adhesion tensile test of a coating

And although in many cases the demands on the adhesive tensile strength were not fulfilled, a loosening of the coating could only be noticed in single cases. In the cases in which extremely low adhesion tensile values of only 0 N/mm<sup>2</sup> to 0.2 N/mm<sup>2</sup> were measured in the final adhesion tensile test, the IKT testers had already noticed cracks in the coating and hollow spots by tapping the coating.
