Nozzle drop test

Nozzle drop test on metromax pipes

Source: IKT eNewsletter, April 2008

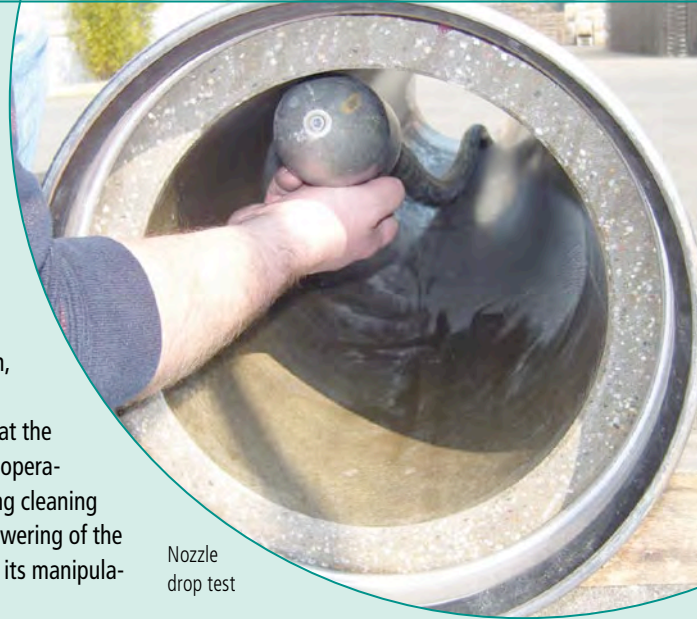
Nozzle drop test

A commercially available omnidirectional nozzle with a weight of 4.5 kg was lifted up to the pipe crown (DN 300) around 50 cm from the pipe joint and then dropped for the purpose of the tests. The nozzle was connected to a rubber DN 32 high-pressure flushing hose, in order to simulate operating practice as authentically as possible. After the descent of the nozzle, the impact surface was examined, and any abnormalities were recorded. Two differing test systems were used, in order to take account of any possible influences exerted by the pipe bedding during the tests.

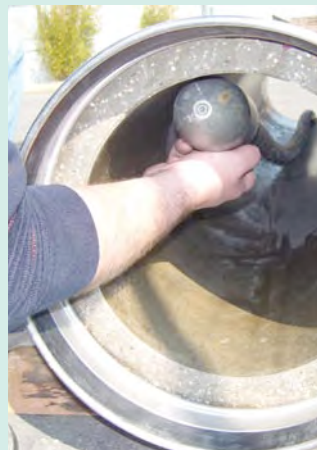
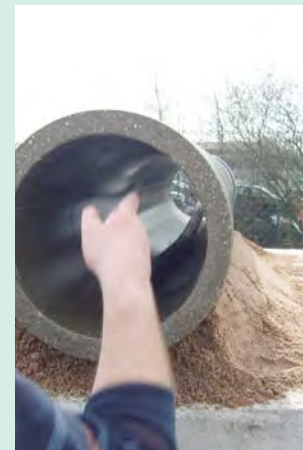
Diagram of system showing bedding of metromax pipes in the nozzle drop test

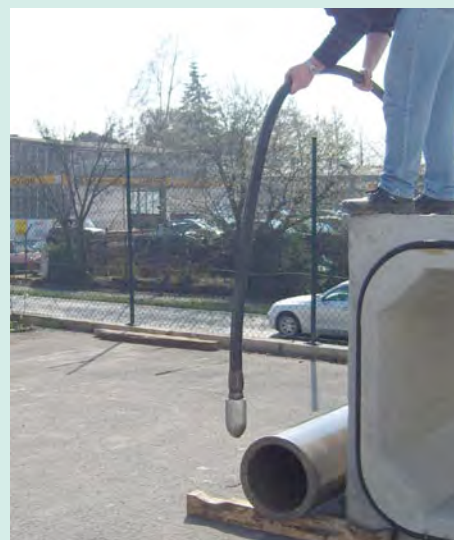
Incorrect, over-energetic insertion of the HP nozzle into the pipe

In addition, the loads exerted on a metromax pipe as a result of incorrect insertion of an HP nozzle into the conduit were also simulated in the context of the „Lowering and manipulation of an HP nozzle“ load situation. For this purpose, the 4.5 kg HP nozzle was swung energetically into the pipe thirty times from an elevated position.

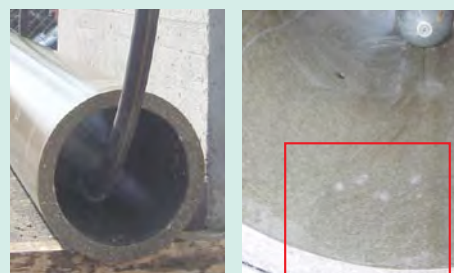
No material abnormalities at or around the pipe joint after five-fold dropping of an HP nozzle

The pipes were visually examined for any material abnormalities after application of the above-described loadings, which are authentic and conform with maintenance and cleaning practice.
