Repair systems: Better than their reputation!

Surprisingly good results in the IKT „Repair Systems“ test

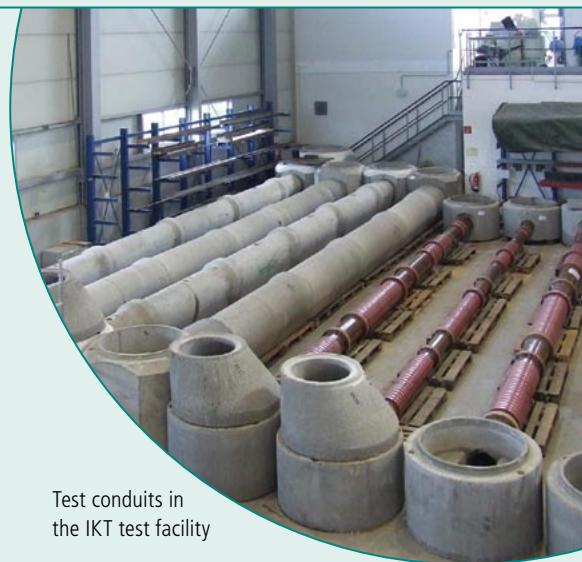
Test conduits in the IKT test facility

Four test lines consisting of concrete and vitrified clay, with nominal diameters ranging from ND 200 to ND 600, and also an additional ND 400/600 oval-section concrete line where the corresponding system could be used, were set up in the IKT test facility for each system for the purpose of the system tests. Typical forms of damage, such as transverse and longitudinal cracking, spalling, fragmentation and leaking joints were artificially incorporated into these conduits. Precisely the same amounts and types

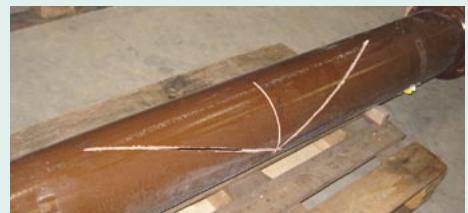
Example of „branching crack“ damage type in vitrified clay pipes

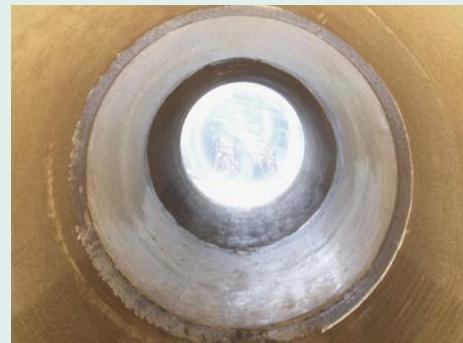
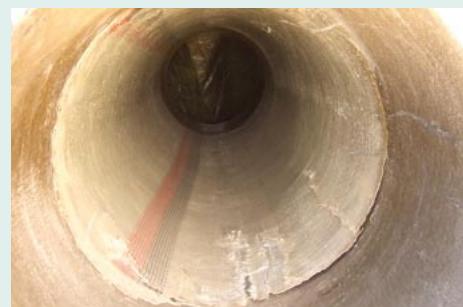
Example of short liners without (top) and with (down) visible traces of high-pressure flushing

In the case of the short liners, the surface, in the base zone, at least, was generally slightly roughened. In individual cases, glass fibers were also exposed, or detachment of material and cracking had occurred. Annular gaps or edges in the boundary zones were also measured on individual short liners.

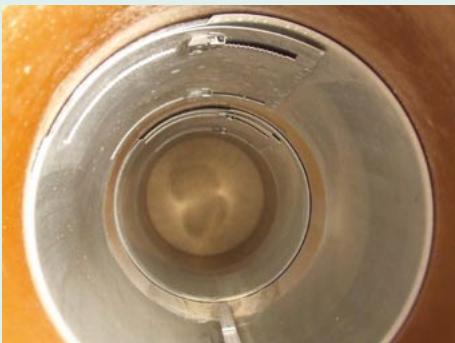
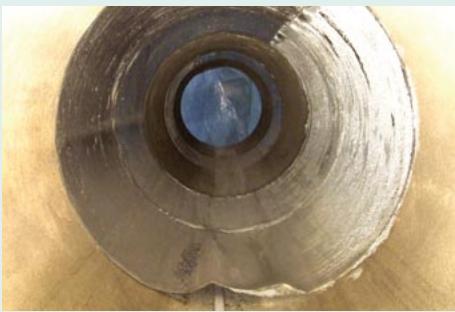
Example of sleeve without (top) and with (down) visible traces of high-pressure flushing

Flushing damage, significant in some cases, in the form of indentations, was observed in the case of the Stuttgarter Hülse, for which an incorrect tooth setting based on the manufacturer's data

had resulted in incorrect tensioning of the sleeve. Edges, in some cases significant, had also formed on some sleeves, due to remnants of resin.

The two Quick-Lock sleeve variants tested produced differing results: in the first model tested, with no flaring, defective teeth on the locking wheel were observed after high-pressure flushing. This caused declining tensioning of the sleeve, with a corresponding reduction in its internal diameter, and therefore leaks. The sleeve subsequently tested, flared at one end, did not exhibit damage of this type. In both variants, upturns of a few millimeters can occur in the overlap zone of the sheet, depending on gap formation.

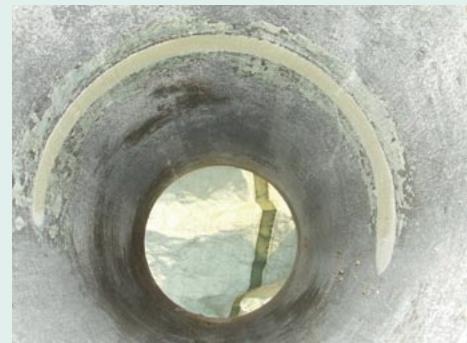
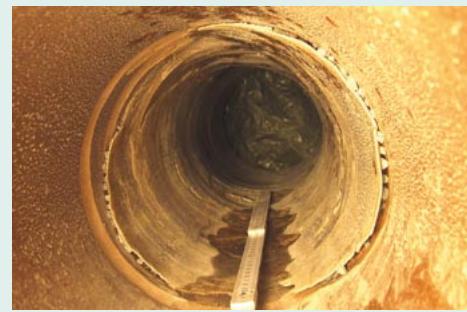
Example of injection/grouting without (top) and with (down) visible traces of high-pressure flushing

In the injection and grouting/pressure-filling group, detachment of material had occurred in some cases in the Janßen Riss- und Scherbensanierung, and in the KASRO 2 Komponenten-Verpresssystem. In most cases, such detachment of material was, it is true, of no importance for the sealing action of the repair and could be removed, but could also form obstructions to flow. In the case of the KA-TE PMO-Verfahren, small upturns on the edges of the resin bodies had occurred at a few points only.
