Tube liner quality reaches celebratory high level!

The tube liner's 40th anniversary found the process in top form; the test results for 2011 are a significant improvement over the previous year's level.

The degree to which claims and reality accorded in this anniversary year is illustrated by the eighth IKT – Institute for Underground Infrastructure LinerReport, presented here. This report

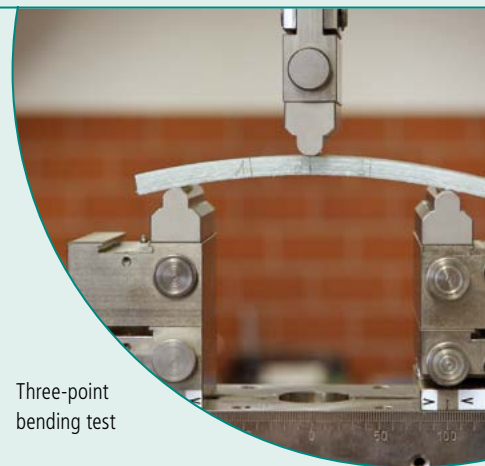
Three-point bending test

- Tube liners must be capable of withstanding loads such as those arising from groundwater, road traffic and soil pressure
- The modulus of elasticity is an indicator of load-bearing capability
- Stability may be endangered if modulus of elasticity is too low
- Test method: Three-point bending test as per DIN EN ISO 178 and DIN EN 13 566, Part 4*
- Results: see Table 2

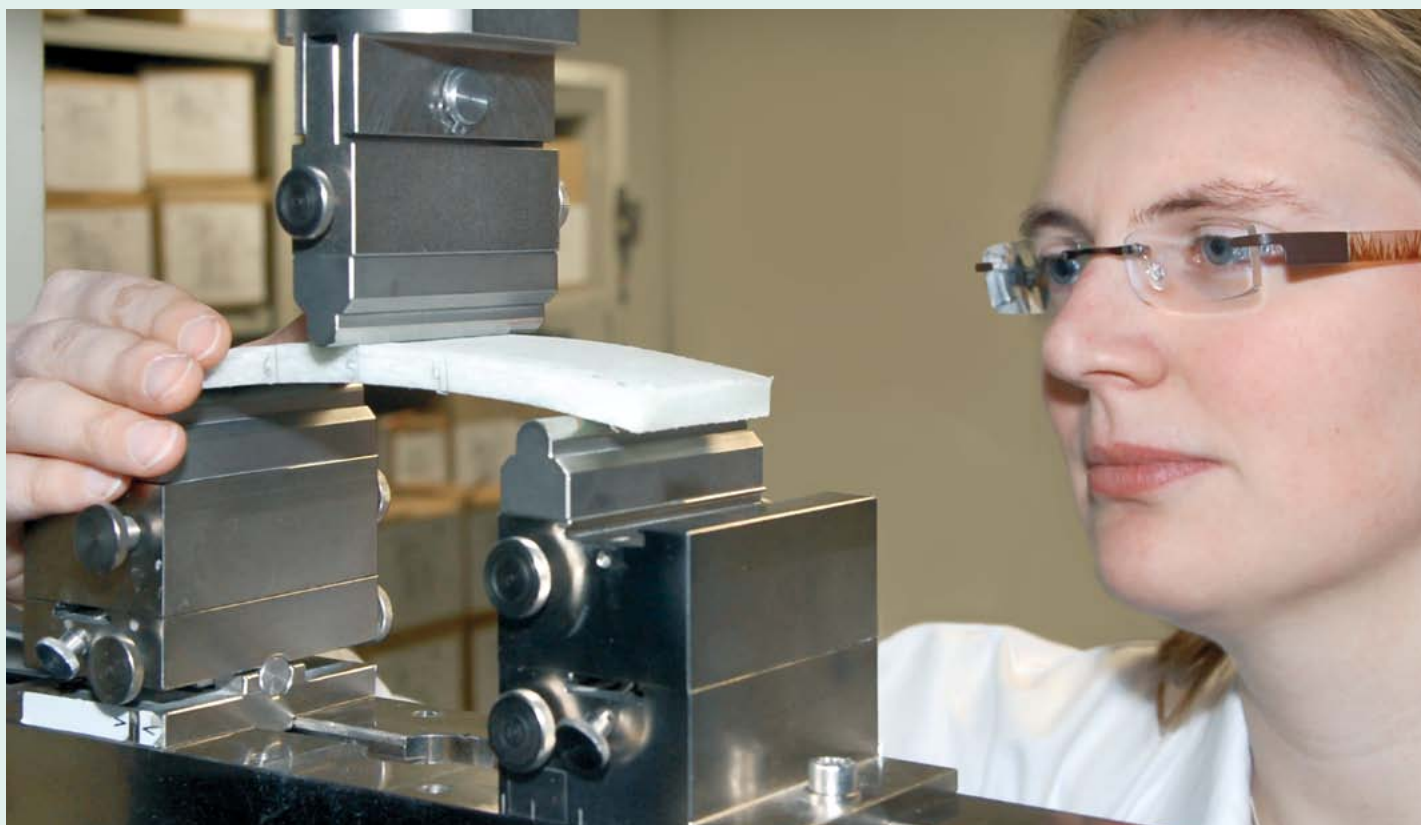
Three-point bending test on a tube liner

- This indicates the point at which the liner fails due to excessively high stress
- If flexural strength is too low, the liner may rupture before the permissible deformation is reached
- Test method: Increase of load up to failure in the three-point bending test; in accordance with DIN EN ISO 178 and DIN EN 13 566, Part 4* (short-term flexural strength)
- Results: see Table 3

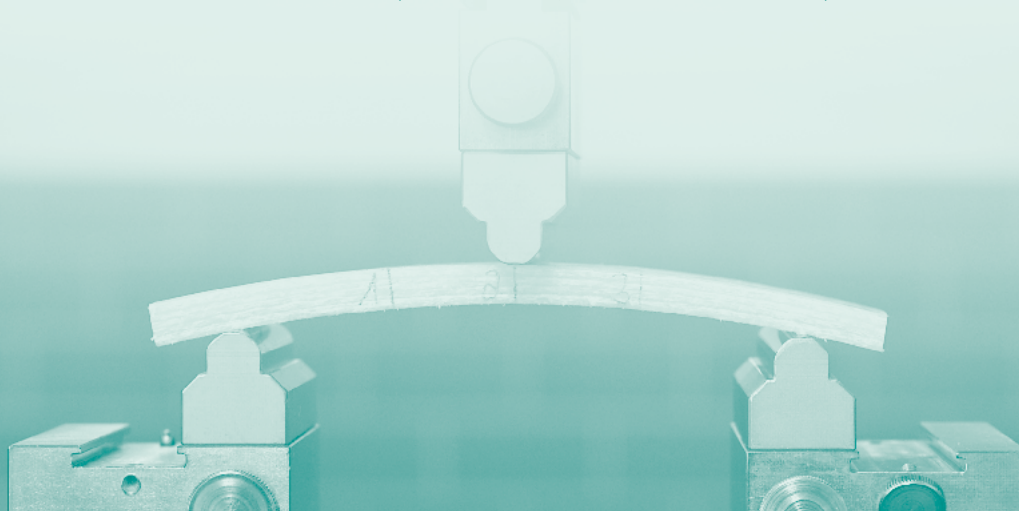
Table 4: Test results for wall thickness (mean combined thickness in accordance with DIN EN 13566, Part 4)

Contractors	2011		2010	Trend
	No. of samples	Target* achieved in % of tests	Target* achieved in % of tests	
Arkil Inpipe GmbH using the Berolina Liner	107	100.0	77.8	↑
Arkil Inpipe GmbH using the Inpipe Liner	42		–	–
Hamers Leidingtechniek B.V. (NL)	27		–	–
Insituform Rohrsanierungstechniken GmbH using the Insituform-Schlauchliner	140		80.0	↑
Jeschke Umwelttechnik GmbH using the Brandenburger Liner	65		–	–
Kanaltechnik Agricola GmbH	42		–	–
KTF GmbH	26		100.0	↔
Max Bögl Bauservice GmbH & Co. KG	69		–	–
Rohr Fuchs Rohrreinigung GmbH	53		98.4	↑
Rohrsanierung Jensen GmbH & Co. KG	36		–	–
Van der Velden Rioleringsbeheer (NL)	32		–	–
Swietelsky-Faber GmbH Kanalsanierung	100	99.0	52.7	↑**
Jeschke Umwelttechnik GmbH using the Alphasliner	83	98.8	100.0	↓
Fleer-Tech GmbH	44	97.7	–	–
Erles Umweltservice GmbH	42	97.6	98.3	↓
KMG Pipe Technologies GmbH using the Saertex Liner	78	97.4	87.9	↑
Umwelttechnik und Wasserbau GmbH	130	96.9	88.0	↑**

Insituform Rohrsanierungstechniken GmbH using the Impreg Liner	31	96.8	88.2	↑
Average		96.2	89.1	↑
Karl Weiss GmbH & Co. KG	46	95.7	70.6	↑
Diringer & Scheidel Rohrsanierung GmbH	60	95.0	100.0	↓**
TKT Jens und Lutz Meißner GbR	150	93.3	98.2	↓
KMG Pipe Technologies GmbH using the Brandenburger Liner	28	92.9	–	–
KATEC Kanaltechnik Müller & Wahl GmbH	35	91.4	–	–
Hertha Ehnes GmbH	34	91.2	–	–
Geiger Kanaltechnik GmbH & Co. KG	22	86.4	–	–
AKS Umwelttechnik GmbH	50	84.0	86.0	↓
Rainer Kiel Kanalsanierung GmbH	68	80.9	96.6	↓
Win-Line GmbH	25	80.0	–	–

* Target values as per client's data (statics / traveller card) | ** Different liner system used in 2010 than in 2011 | – Not evaluated, too few liner samples

In the past, wall thickness has been the test criterion in which GRP liners regularly performed more poorly than NF liners. This remains the case in 2011, but on the basis of a significantly higher average score of 96.2% (+7.1 %P) achieved by all samples. Both GRP and NF liners have improved significantly compared to the previous year, by +7.1 %P, to 95.8%, and by 8.2 %P, to 99.5%, respectively.

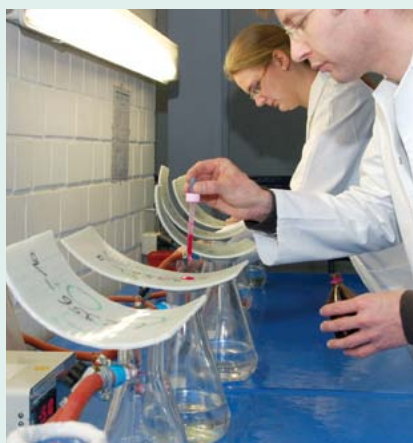
Tightness testing of tube liners

- A cut is made into the inner film if the latter is not an integral component of the liners; the outer film (if any) is removed
- Water containing a red dye is applied internally
- A 0.5 bar partial vacuum is applied externally
- The liner is „Not tight“ if water penetrates through
- Test period: 30 min.
- Results: see Table 5
