**IKT-LinerReport 2007**

**Tube liner quality in 2007:**

# An improvement over last year

## **Tube liner quality in 2007:**

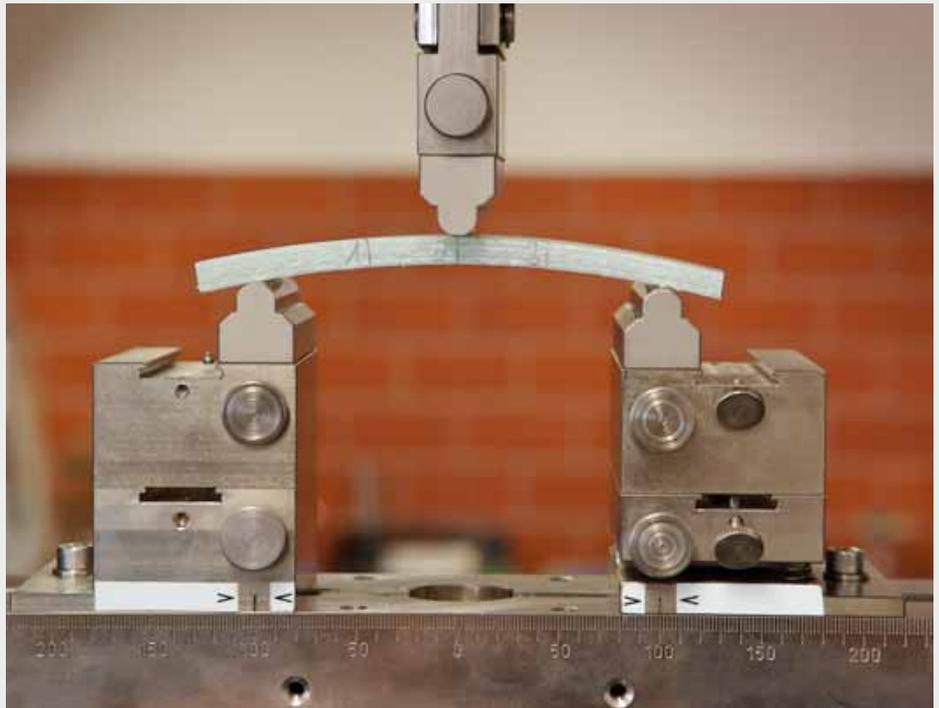
Figure 1: Liner sample undergoing the three-point bendig test

- Tube liners must be capable of withstanding loads such as those arising from groundwater, road traffic and soil pressure, for example
- The modulus of elasticity is an indicator of load-bearing capability
- If it is too low, stability may be endangered
- Test method: Three-point bending test as per DIN EN ISO 178 and DIN EN 13 566, Part 4
- Results: see Table 2

- This indicates the point at which the liner fails due to excessively high stress
- If bending strength is too low, the liner may fracture before the permissible deformation is reached
- Test method: Increase of load up to failure in the three-point bending test; as per DIN EN ISO 178 and DIN EN 13 566, Part 4 (short-term flexural strength)
- Results: see Table 3

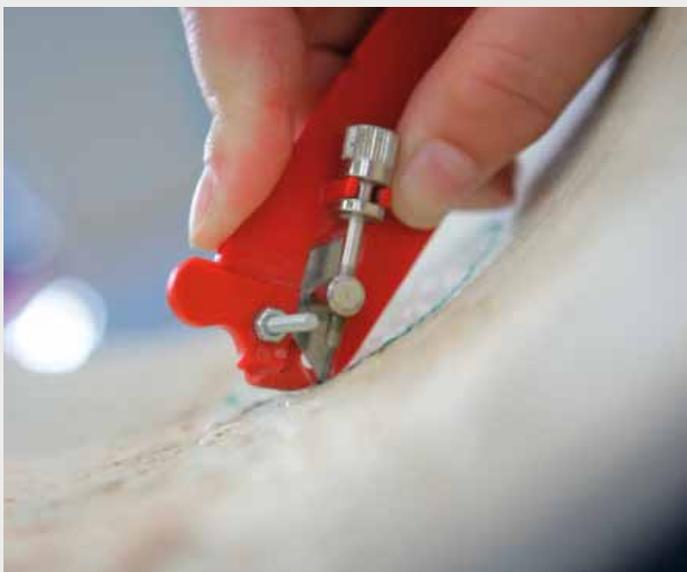
Figure 2: Cut made into inner film, with limitation of cut depth

- Cut is made into inner film and the outer film (if any) is removed
- Water containing a red dye is applied internally
- A 0.5 bar (7.25 psi) partial vacuum is applied externally
- The liner is „Not tight“ if water penetrates through
- Test period: 30 min.
- Results: see Table 5

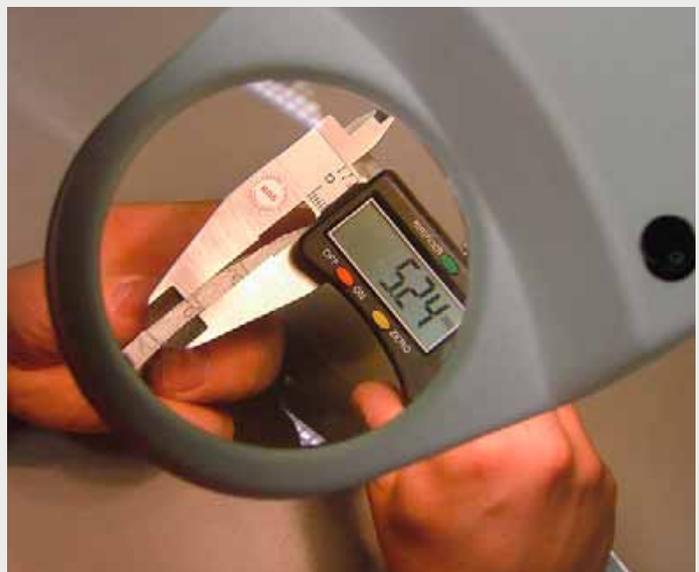
Figure 3: Measurement of liner-wall thickness

- Minimum value is specified in the stress analysis calculation
- Wall thickness and modulus of elasticity jointly determine the stiffness of the liners
- Excessively low wall thickness can endanger stability
- Test method: Mean combined thickness is measured in accordance with DIN EN 13 566, Part 4, using a precision slide gauge
- Results: see Table 4
