**IKT-LinerReport 2007**

**Tube liner quality in 2007:**

# An improvement over last year

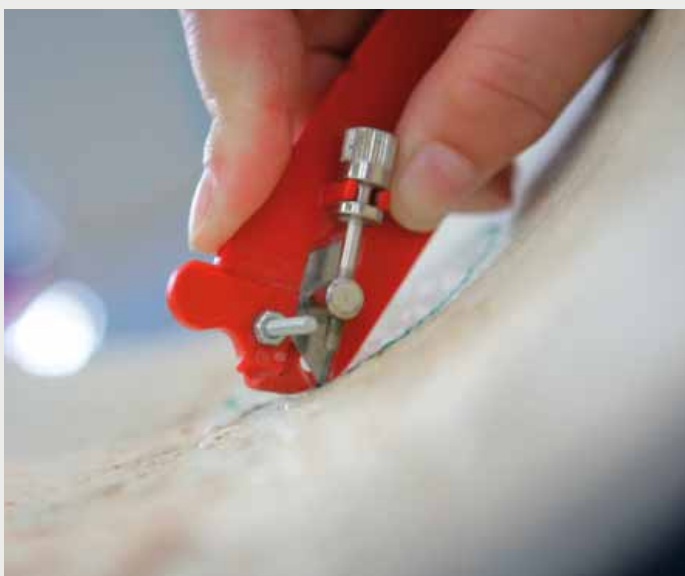
Figure 2: Cut made into inner film, with limitation of cut depth

- Cut is made into inner film and the outer film (if any) is removed
- Water containing a red dye is applied internally
- A 0.5 bar (7.25 psi) partial vacuum is applied externally
- The liner is „Not tight“ if water penetrates through
- Test period: 30 min.
- Results: see Table 5

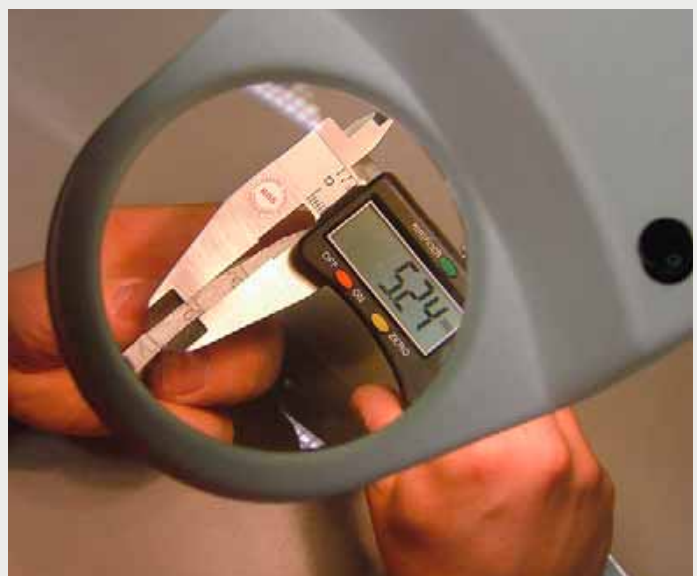
Figure 3: Measurement of liner-wall thickness

- Minimum value is specified in the stress analysis calculation
- Wall thickness and modulus of elasticity jointly determine the stiffness of the liners
- Excessively low wall thickness can endanger stability
- Test method: Mean combined thickness is measured in accordance with DIN EN 13 566, Part 4, using a precision slide gauge
- Results: see Table 4

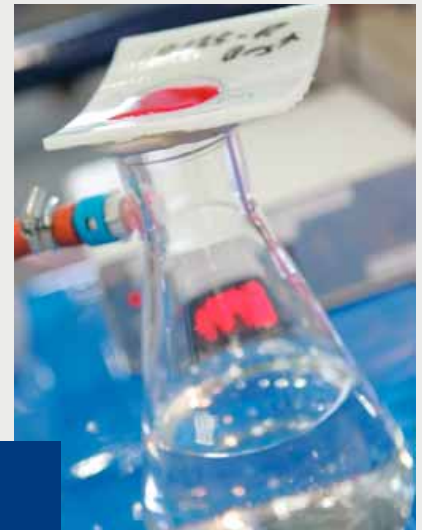
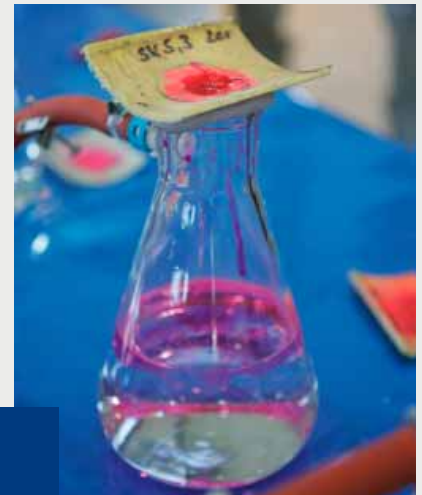
**Figure 4: Tightness test****Table 6: Test results classified by liner types**
