# TESTING TOP HAT LINERS AND ROBOTIC SYSTEMS FOR REPAIR OF LATERAL CONNECTIONS

Dr.-Ing. Bert Bosseler, Dipl.-Ing. Gunter Kaltenhäuser

IKT - Institute for Underground Infrastructure, Exterbruch 1, 45886 Gelsenkirchen,  
Germany, e-mail: bosseler@ikt.de; kaltenhaeuser@ikt.de

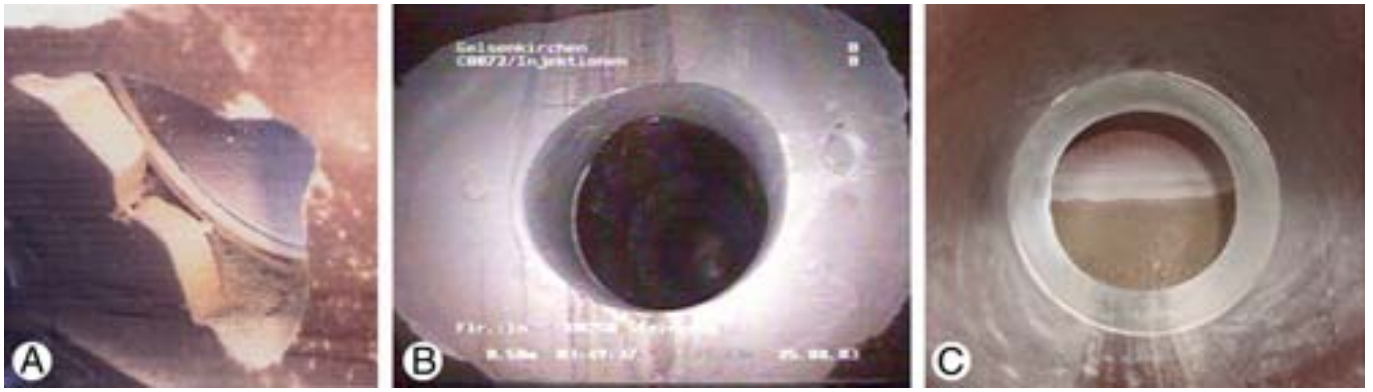
Figure 2. Standard damage for robotic systems and example of a visually satisfactory repair result. **A** Initial situation. **B** View from the main pipe. **C** View into the connecting pipe.

Unprofessionally installed lateral connection with strong borehole damage due to cracking and shard formation in a stoneware pipe DN 250 with stoneware connecting pipes DN 150 (see Figure 2 A).

The prepared damages were repaired in the appropriate test sections with the chosen methods. The participating network operators then assessed the re-establishment of the lateral connection operability by visual impression of the repairs. The respective standard damages were repaired visually satisfactory with the robotic systems and top hat liners (Figure 2 and Figure 3). Only three offerers could visually satisfactory repair the extreme damages foreseen for robotic systems (Figure 4). This can among other things be attributed to the applied technology. Some methods were e.g. not able to seal pipes connected in an acute angle with the inflatable piston or ballon for sealing the connecting pipe. The extreme damages for the top hat liners were only repaired visually satisfactorily by two offerers (Figure 5). Numerous repairs of the respective extreme damages were not visually satisfactory. The repair even worsened the condition of the lateral connections in some cases (Figure 6). In nearly all cases the top hat liner resin impregnation was only accomplished manually (Figure 7 A). A complete top hat liner surface impregnation cannot therefore be ensured. Only one offerer vacuum impregnated the top hat liner, thereby promoting complete impregnation (Figure 7 B).

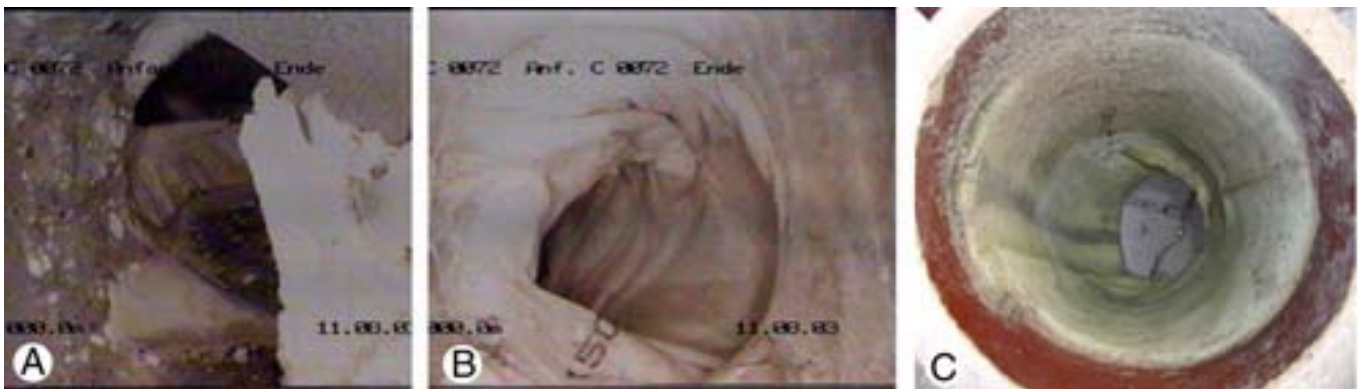
Figure 6. Examples of visually unsatisfactory repair results on extreme damages **A** Robotic system - view from the main pipe. **B** Top hat liner - view from the main pipe. **C** Top hat liner - view into the connecting pipe (after disassembly).

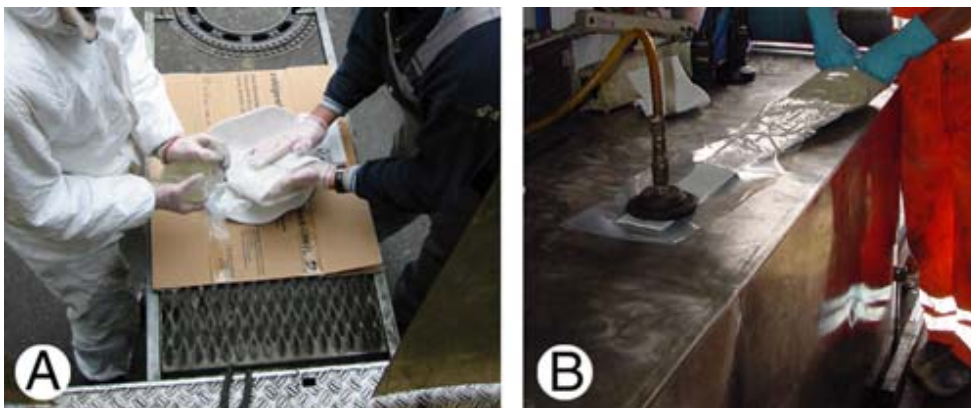
Figure 7. Top hat liner resin impregnation **A** Only manual resin impregnation. **B** Vacuum resin impregnation.

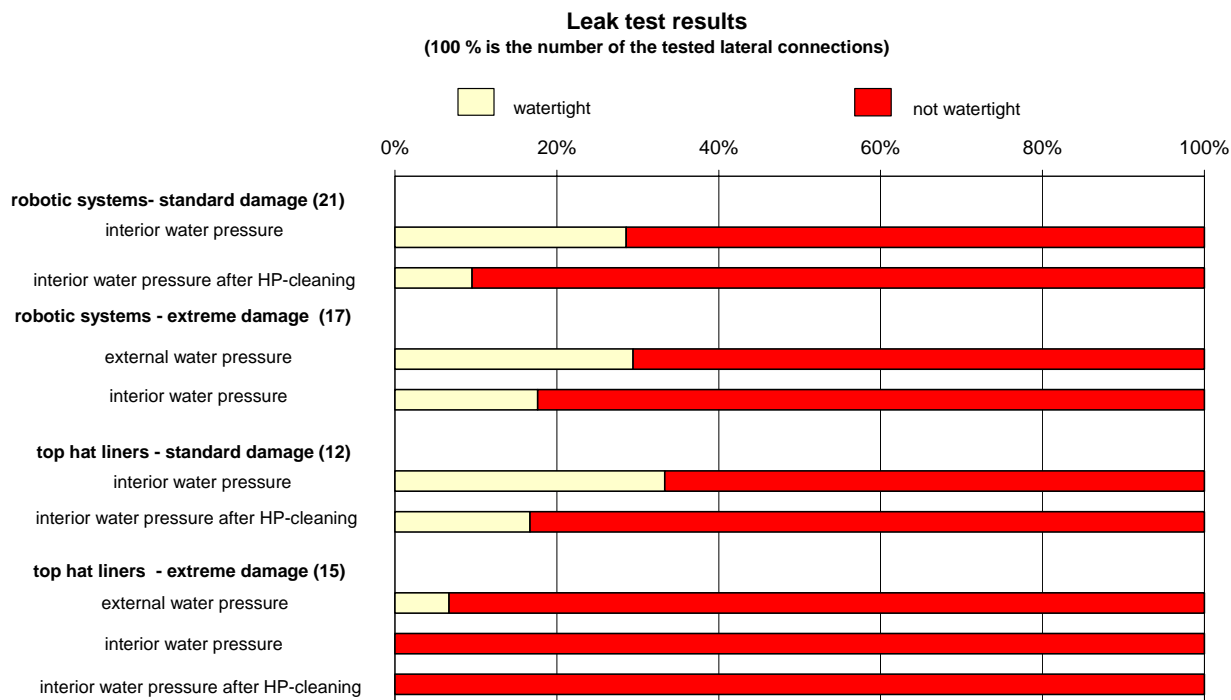
Figure 8. Leak test results

Waterproof testing with exterior and interior water pressure was carried out immediately after the repair. A renewed examination of the leak was carried out with interior water pressure after high-pressure flushing stress. Figure 8 summarises these leak test results. Altogether 21 standard or extreme damages were repaired with robotic systems and 12 and/or 15 damages were repaired with top hat liners. In the case of robotic systems applied to repair extreme damages only 17 of 21 leak tests were considered in the final evaluation because an influence of later repairs at other locations could not be excluded with regard on four connections.

The majority of the repairs leaked during the external and/or internal water pressure leak tests. Leakages were ascertained in over 70% of the standard damage lateral connections repaired with robotic systems and in almost 70% of the standard damage lateral connections repaired with top hat liners at an interior water pressure of 0,1 bar. Over 70% of the extreme damage lateral connections repaired with robotic systems leaked at an external water pressure at pipe crown level; over 80% of the connections leaked during application of interior water pressure. Over 90% of the top hat liners, with which extreme damages were repaired, leaked under external water pressure (50 cm over pipe crown) and 100% with application of interior water pressure. The high-pressure flushing of the repair locations resulted in leaking lateral connections, even though they were impermeable immediately after repair.
