Inspection and Condition Assessment of Pressure Pipes

Abdelhamid Bedjou, Magister of Hydraulic

IKT, Germany

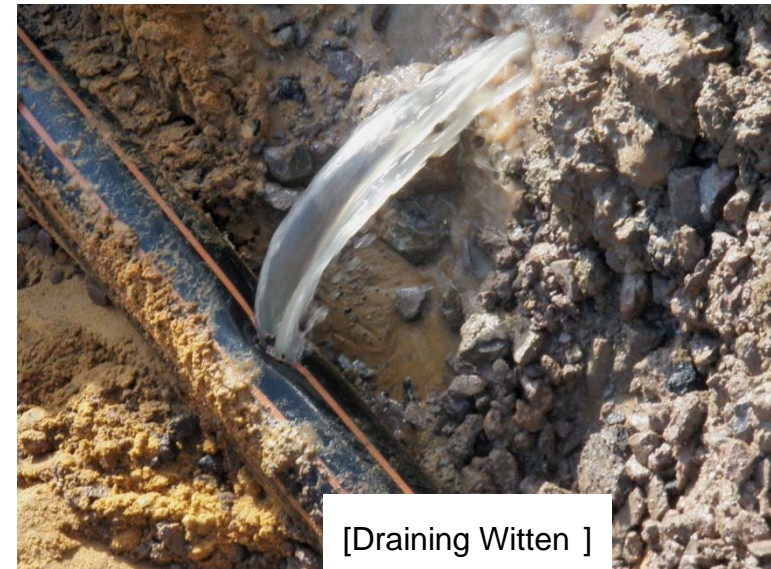
PE/PVC

- Faulty Connection
- Deformations
- Longitudinal Cracks
- Ring Cracks
- Material Defects / Fatigue
- Leakages (Episode)
- (Damage by third parties)

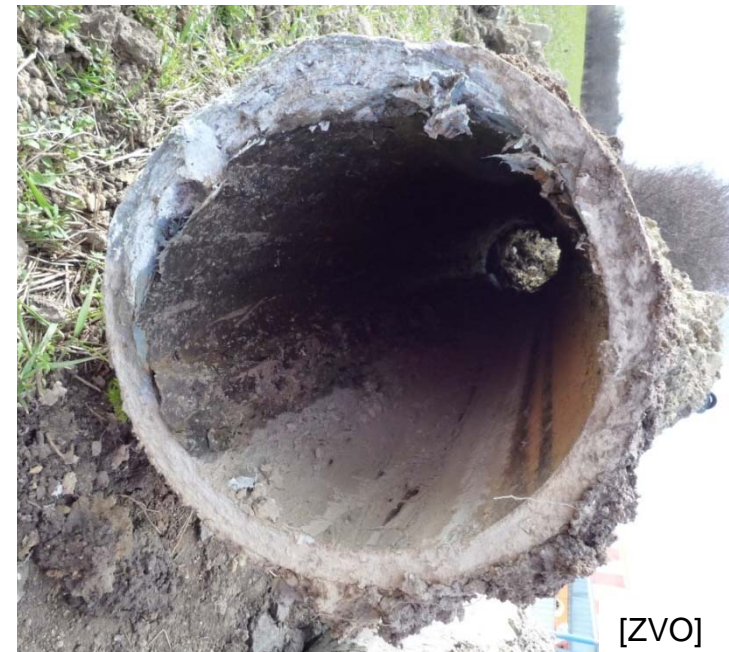
Asbestos cement

- Corrosion (inside/outside)
- Wall Thickness Loss / Holes
- Cracking
- Body Formation
- Leakages (Episode)
- Abrasion
- (Damage by third parties)

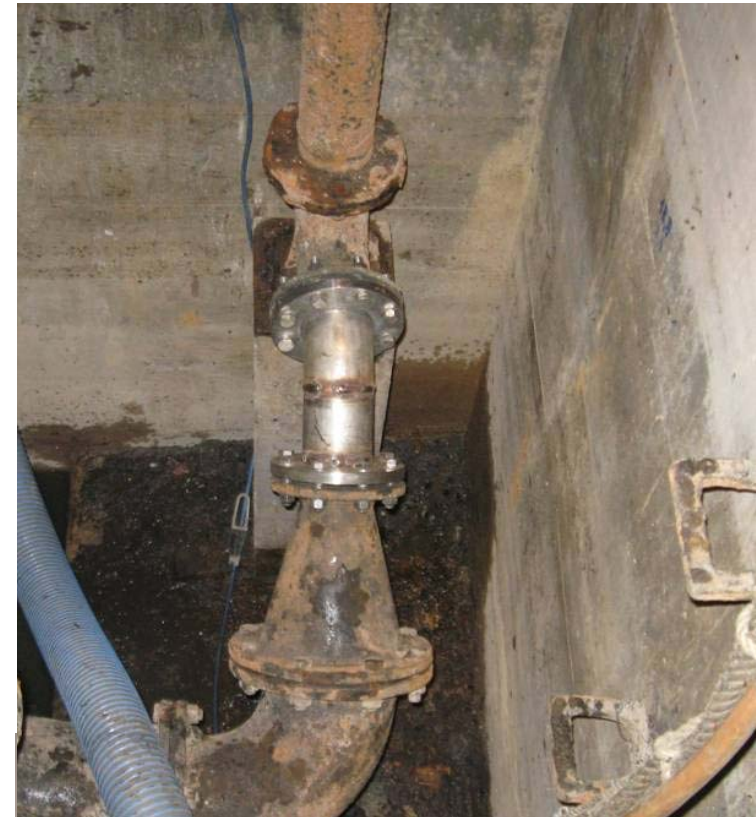
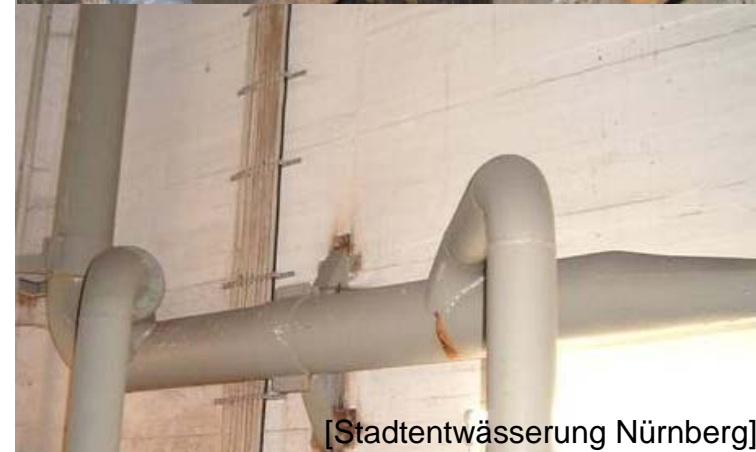
Steel

- Corrosion inside/outside
 - Surface-Corrosion
 - Troughs-Corrosion
 - Hole-Corrosion
 - Grain-Corrosion
- Leaking Connections
- Longitudinal Crack
- Circular Crack
- Deformation
- Abrasion of Corrosion Coating
- (Damage by third parties)

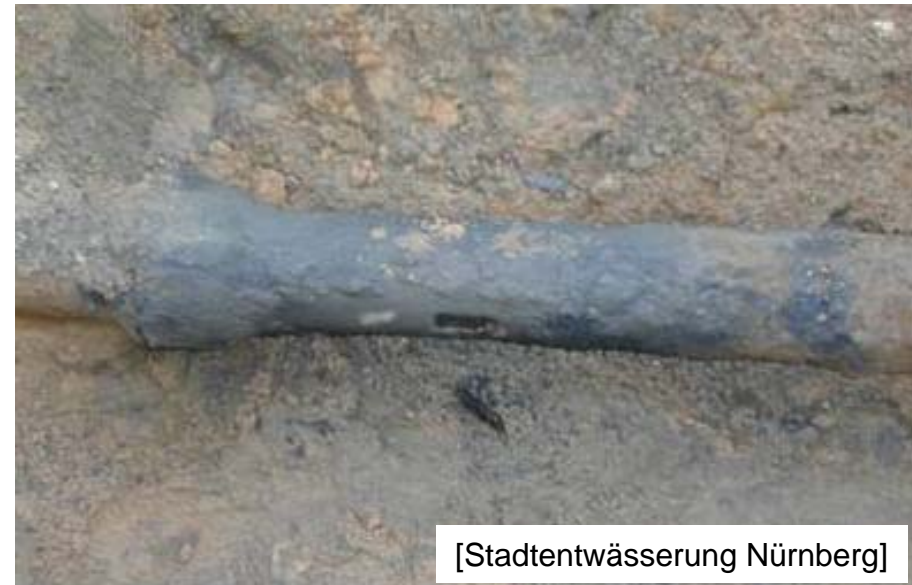
Cast

- Corrosion innen/außen
 - Surface-Corrosion
 - Troughs-Corrosion
 - Hole-Corrosion
 - Grain-Corrosion
 - Gaphitization
- Leaking Connections
- Transverse Fracture
- Shell Breakage
- Longitudinal crack
- circular Crack
- Deformation
- Abrasion of Corrosion Coating
- (Damage by third parties)

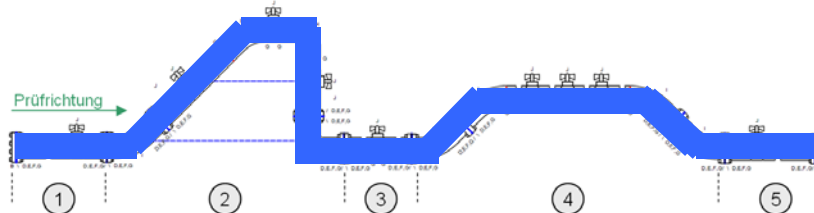
Pipe completely filled with water

Tests	Preliminary Test				Pressure Drop Test	Main Test	
	Relaxation	Pressure build-up	Keep pressure	Resting phase			
Condition 1 (8bar)	✓	✓	✓	✓	X	-	Cancel- leaks not detected
Condition 2 (8bar)	✓	✓	✓	✓	X	-	Cancel - Leaks not detected
Condition 3 (8bar)	✓	✓	✓	✓	✓	✓	passed, Given leaks
Condition 3 (4bar)	✓	✓	✓	✓	✓	✓	passed, Given leaks
