IKT LinerReport 2020

# CIPP liners meeting target values at six-year low

One liner sample in eight did not meet its target value for at least one of the four test criteria

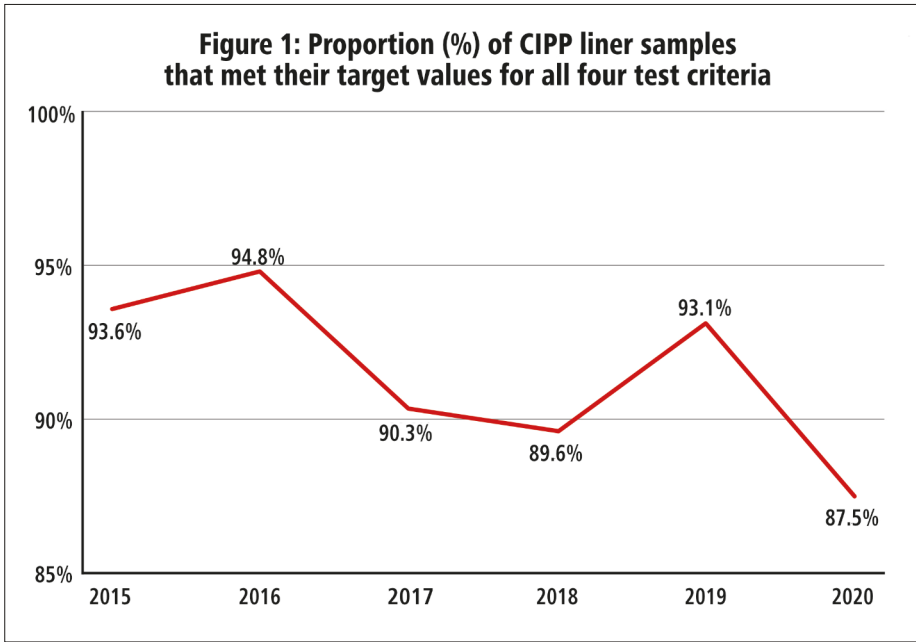
In 2020, only 87.5% of the CIPP liner samples passed all four test criteria at the same time, and 12.5% did not. In other words: every eighth installed CIPP liner sample tested was below the stated target value for at least one of the four required material parameters. This is the lowest level in the past six years. In the previous year, the comparative value was 93% and in 2016 it was 95% (Figure 1).

These percentages refer only to those samples for which target values were provided for all four criteria. They represent three quarters of all samples, i.e. 1,978. For a quarter of the samples (= 635), the target value for at least one test criterion was not provided to the Institute, or one or more of the four tests were not commissioned by the contractor or sewer network owner that submitted the sample for testing. Of the samples for which all four target values were provided for all four tests:

- < 0.1% passed only one test criterion
- 1.2% passed only two test criteria
- 11.3% passed three test criteria
- 87.5% passed all four test criteria
