Practical experience and test concepts

Application of large profiled plastic pipes

Source: Bosseler, Sokoll, Falter, Holthoff: bi UmweltBau 5/2006

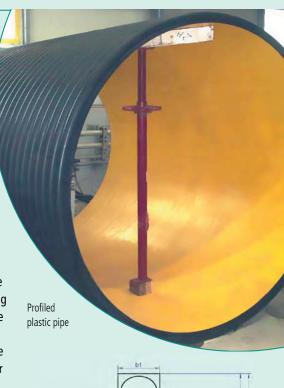
Figure 1: Large profiled plastic pipe ND 2000 during the experiment: pipe deformation and water tightness testing of the connections
