Rehabilitation of waste-water manholes: Large-scale tests and in-situ studies

IKT's recently completed research report on the "Rehabilitation of waste-water manholes" focuses on two central topics: the sealing of the manhole structure and in- and outlets, and coating using mineral and polymeric systems.

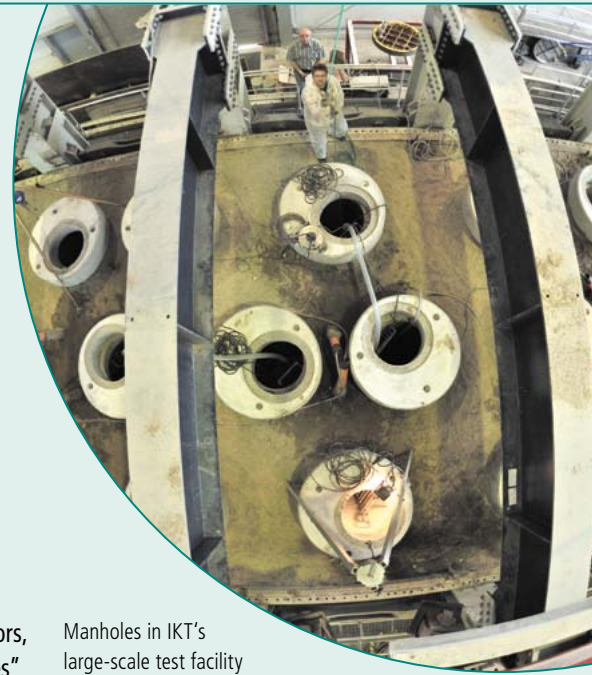
Manholes in IKT's large-scale test facility

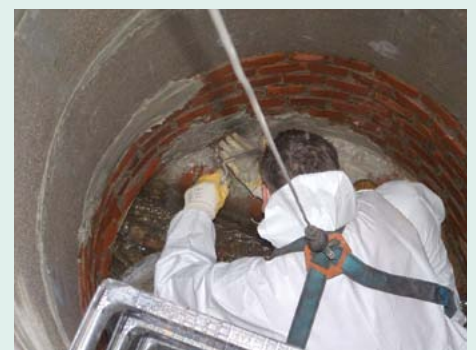
Sealing work in practice: cementitious waterproof plugging compound

On the basis of this scenario, **sealing provisions** will now be performed, in order to temporarily restore the manhole's tightness. The visible leaks in the manhole will be systematically sealed using the most diverse range of materials and methods up to the level of the current groundwater table in order to achieve this. Mineral- and polymer-based materials are used for this purpose, and are either applied manually to the inner walls of the manhole, or injected into the manhole surroundings using injection packers and pumps. The geometry of the structure is generally significantly modified during these processes. Such work is normally performed during the summer months, when groundwater tables are low.

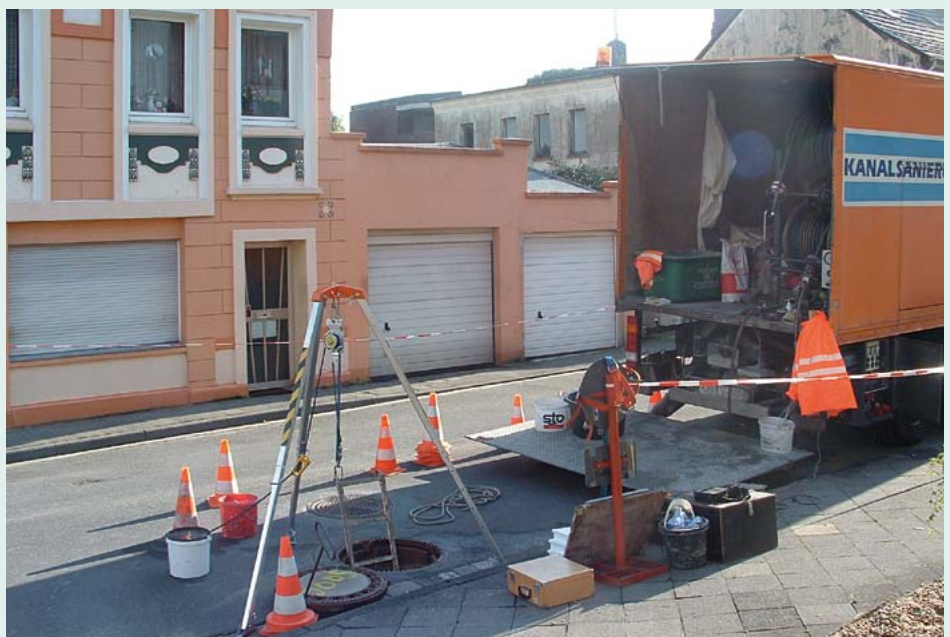
Manhole renovation in practice

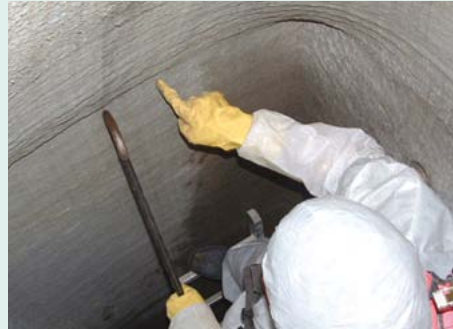
Acceptance inspection: visual assessment of the coating

Complete curing (hardening) of the materials applied, completion of all finishing work and after-treatments is followed by acceptance inspection. This will involve visual inspection of the coating, tapping of it to detect any cavities, and the determination of tensile adhesion data for the bond with the substrate.

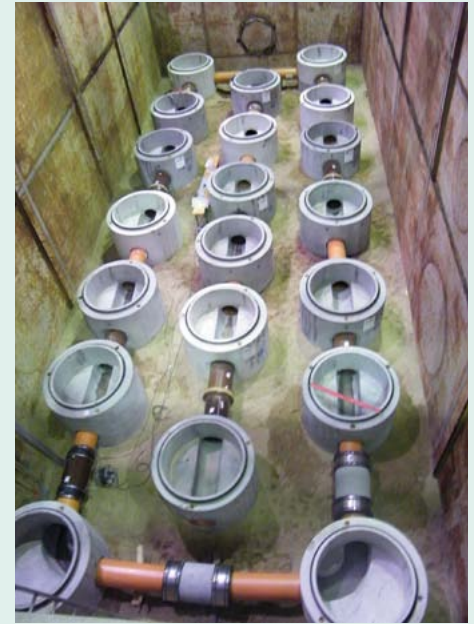
Installation of the manholes in the large-scale test facility

the renovation conditions under examination. A total of twenty manhole structures consisting of prefabricated concrete elements were installed in a mixture of gravel and sand with a maximum particle size of 8 mm in the IKT large-scale test facility. The manholes had an internal diameter of 1000 mm (DN 1000) and a total structure height of around 5.6 m. Conduits and manhole linings of DN 300 were installed in the lower manhole sections. Stoneware and PVC-KG pipes were connected to the manhole linings installed.

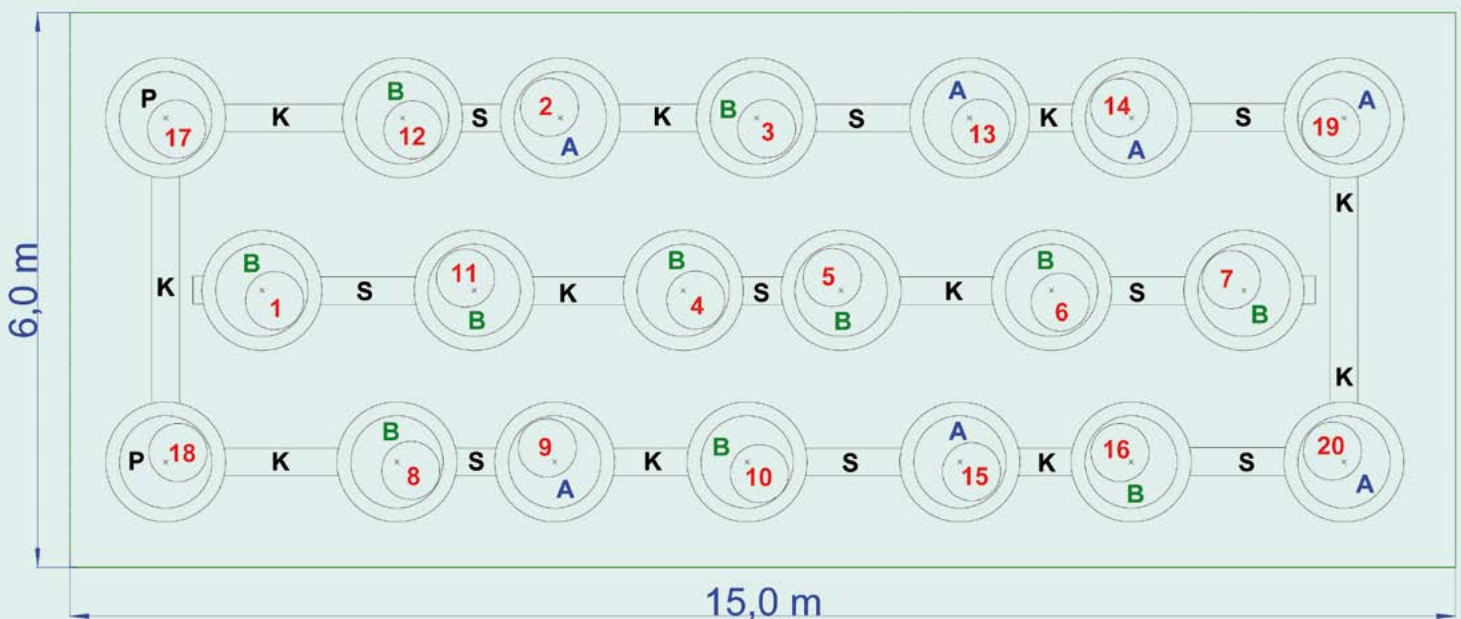
Diagram (plan view) of the manhole structure in the large-scale test facility

A: Manhole for sealing provisions; B: Manhole for coating provisions;
P: Pump shaft; K: PVC pipe; S: Stoneware pipe

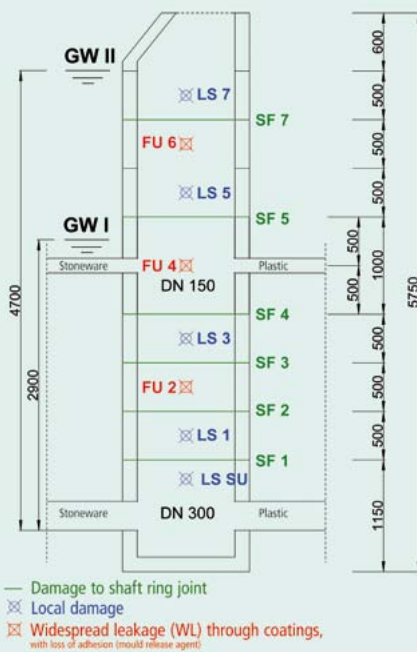
Faults deliberately incorporated into manholes intended for coating: side view of the manhole structure (left) and damage patterns (right)

Various geometrical faults were incorporated into the shaft rings and lower sections prior to and during installation of the prefabricated concrete elements. These simulated local and widespread leaks, and also leaking shaft ring joints, and took the form, essentially, of varying numbers of drilled holes of various sizes. A mould release agent for intentional weakening of the bond was applied to the "large-area leak" point of damage after completion of substrate preparation, but prior to coating.

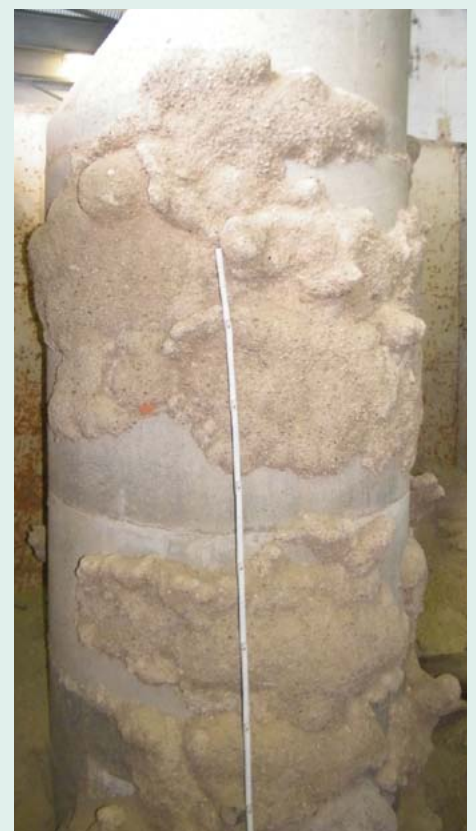
Polyurethane injection body on the exterior of a manhole

Under exposure to external water pressure for a number of days in the large-scale test, resins and gels achieved good sealing of the damaged manholes. They are, therefore, also suitable as a preparatory measure for coating. Virtually all the resins and gels exhibited significant leaks after more prolonged exposure to external water pressure (around five months). Cementitious waterproof plugging compounds, on the other hand, exhibited a significantly poorer sealing action, even in the short term; their use is recommendable primarily for initial sealing of severe influxes of water, by way of preparation, for example, for more extensive injection sealing. Injection of a cement paste involved fundamental difficulties, due to the comparatively slight cavity/pore size of the well compacted surrounding gravel/sand soil used in the test.
