IKT - Institute for Underground Infrastructure

Coatings for a watertight manhole shaft

IKT Comparative Test "Manhole Rehabilitation"

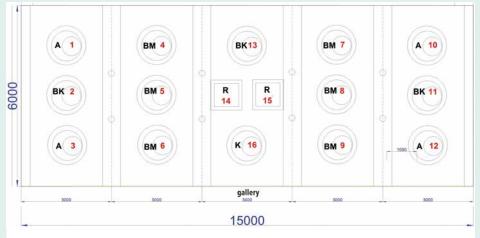
A = manhole with lining, BM = manhole with mortar coating, BK = manhole with plastic coating, K = plastic manhole, R = manhole manhole manhole for mortar coating, Red figure = manhole number

All according to plan: thirteen manholes set up for the Comparative Test and three for supplementary investigations

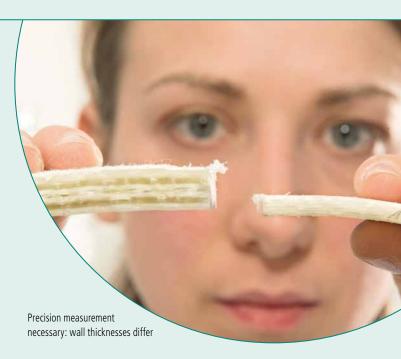
Overview of test and inspection criteria

Four characteristics are analysed for each of the samples taken on site: modulus of elasticity, flexural strength, wall thickness and water-tightness. The Actual data is compared against the Target data from the DIBt (German Institute for Building Technology) approvals and against any divergent Target specifications by the client. The Target values for wall thickness are either defined on the basis of structural-analysis calculations or are specified by the client. Two procedures are used for the testing of the watertightness of needle-felt liners: with and without cutting of the inner film. The latter method is selected for liners, the DIBt approval - or, in the Netherlands, the KOMO Foundation certificate - for which confirms the inner film as an integral element with an influence on tightness. The inner film of all other needle-felt liners is cut. GRP liners which do not have an inner film which remains in the sewer are tested without cutting.

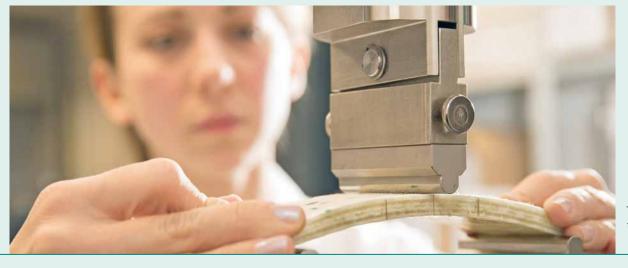
Three-point bending test on CIPP liners

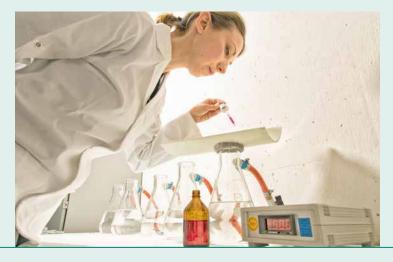
Tightness testing of CIPP liners

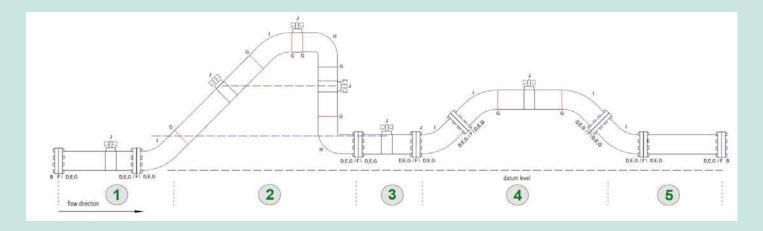
Test length of plastic pipe subdivided into sections with numbered valves

IKT also performed supplementary tests on the sample pipe address other concerns expressed by the sewage network operators about water tightness tests on existing pipelines. In these the test criteria and boundary conditions were varied, and the results compared against one another. Questions on the extent to which limits can be determined and DIN EN 805/DVGW W

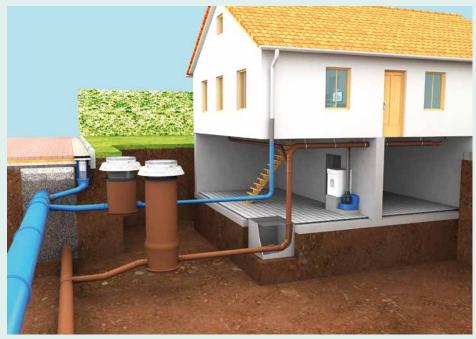
Site drainage system in accordance with generally accepted standards of technology

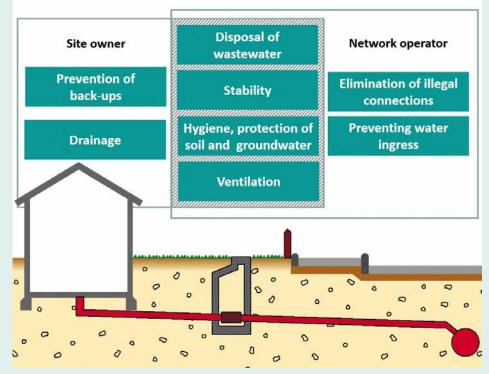
Requirements for private site drainage systems

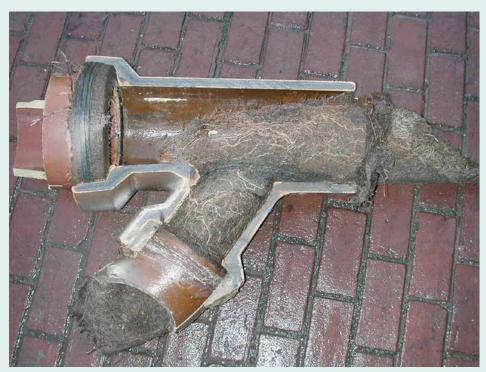
Root intrusion into private sewer laterals

In certain cases, there may also be a public responsibility for the elimination of obstructions to flow. A particular case is in public roads where the intrusion of roots from municipal trees or from roadside greenery into private sewer laterals may occur. In many cases, the owner of the tree bears co responsibility for eliminating root intrusion ([8], Article 1004 German Civil Code [9]).

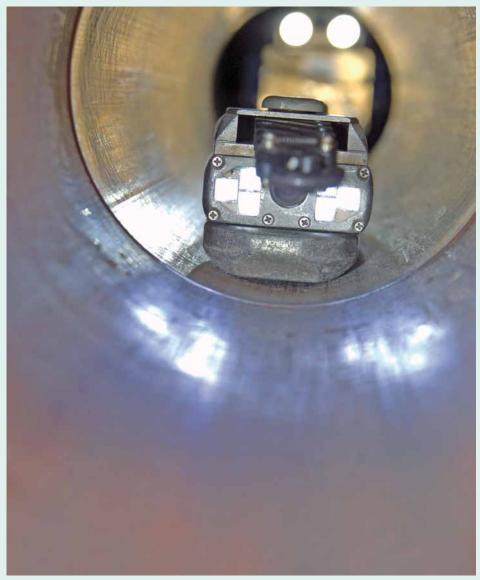
Condition and function of private sewers must be surveyed

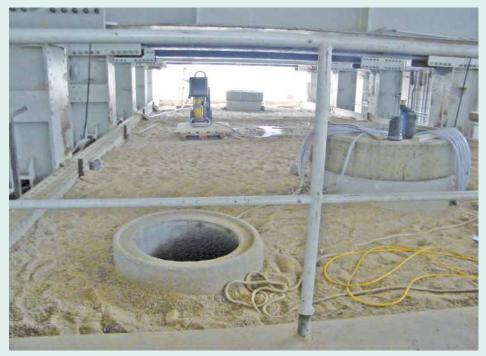
A giant sandpit: IKT's 6 m deep large-scale test facility can be flooded.

Schacht + Trumme W. Schwarz GmbH, of Ahrensburg Germany, wanted to know whether their HDPE manhole lining would withstand continuous exposure to external water pressure, so they commissioned a test by IKT. The lining was installed into a systematically "pre-damaged" manhole structure consisting of prefabricated concrete elements in IKT's large-scale test facility.

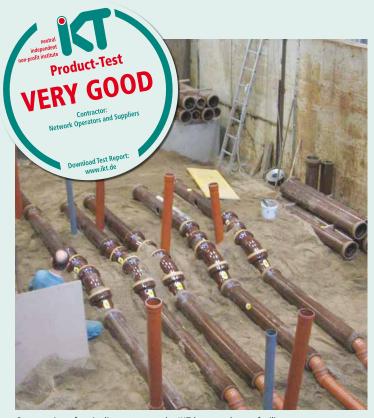
Construction of a pipeline system at the IKT large-scale test facility
