**IKT-LinerReport 2008**

# Tube liner quality: Variegated trend

Tube liners improved on a broad front in 2007, whereas 2008 has brought both advances and retreats. Where are the potentials for improvement in individual liner systems?

**BY DIPL.-ÖK. ROLAND W. WANIEK  
AND DIPL.-ING. DIETER HOMANN**

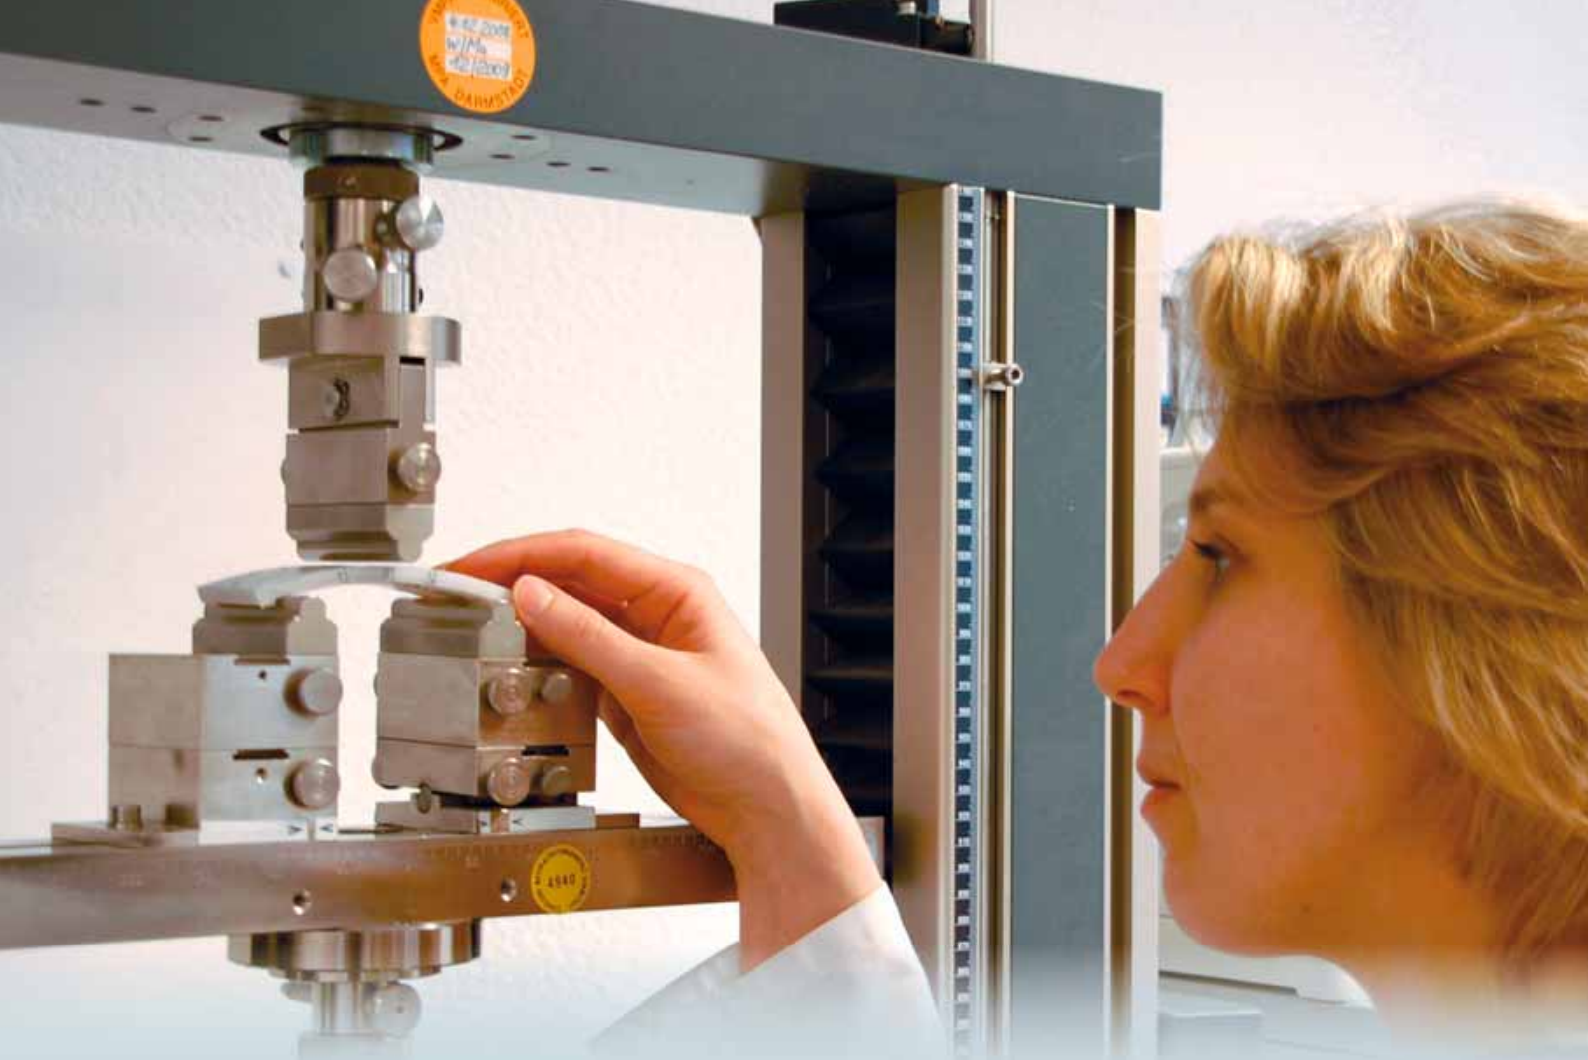
Test engineer Tatjana Kijan preparing a three-point bending test

<p><b>Flexural strength (short-term <math>\sigma_{fb}</math>)</b></p> <ul style="list-style-type: none"> <li>• This indicates the point at which the liner fails due to excessively high stress</li> <li>• If bending strength is too low, the liner may fracture before the permissible deformation is reached</li> <li>• Test method: Increase of load up to failure in the three-point bending test; as per DIN EN ISO 178 and DIN EN 13 566, Part 4 (short-term flexural strength)</li> </ul> <p>→ Results: see Table 3</p>	<p><b>Water tightness (in accordance with APS test and inspection code)</b></p> <ul style="list-style-type: none"> <li>• Cut is made into inner film and the outer film (if any) is removed</li> <li>• Water containing a red dye is applied internally</li> <li>• A 0.5 bar (7.25 psi) partial vacuum is applied externally</li> <li>• The liner is „not tight“ if water penetrates through</li> <li>• Test period: 30 min.</li> </ul> <p>→ Results: see Table 5</p>

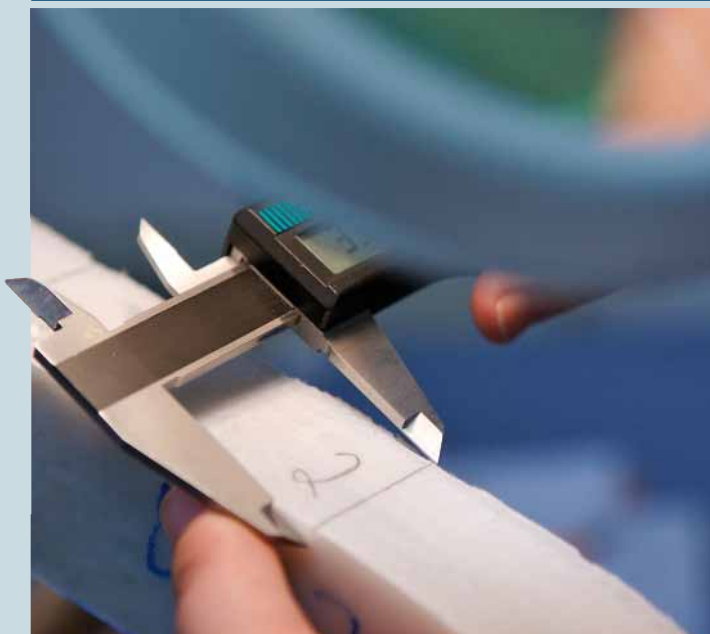
Liner wall-thickness is measured using a precision slide caliper gauge

<p><b>Modulus of elasticity (short-term flexural modulus)</b></p> <ul style="list-style-type: none"> <li>• Tube liners must be capable of withstanding loads such as those arising from groundwater, road traffic and soil pressure, for example</li> <li>• The modulus of elasticity is an indicator of load-bearing capability</li> <li>• If it is too low, stability may be endangered</li> <li>• Test method: Three-point bending test as per DIN EN ISO 178 and DIN EN 13 566, Part 4</li> </ul> <p>→ Results: see Table 2</p>	<p><b>Wall thickness (mean combined thickness)</b></p> <ul style="list-style-type: none"> <li>• Minimum value is specified in the stress analysis calculation</li> <li>• Wall thickness and modulus of elasticity jointly determine the stiffness of the liners</li> <li>• Excessively low wall thickness can endanger stability</li> <li>• Test method: Mean combined thickness is measured in accordance with DIN EN 13 566, Part 4, using a precision slide gauge</li> </ul> <p>→ Results: see Table 4</p>

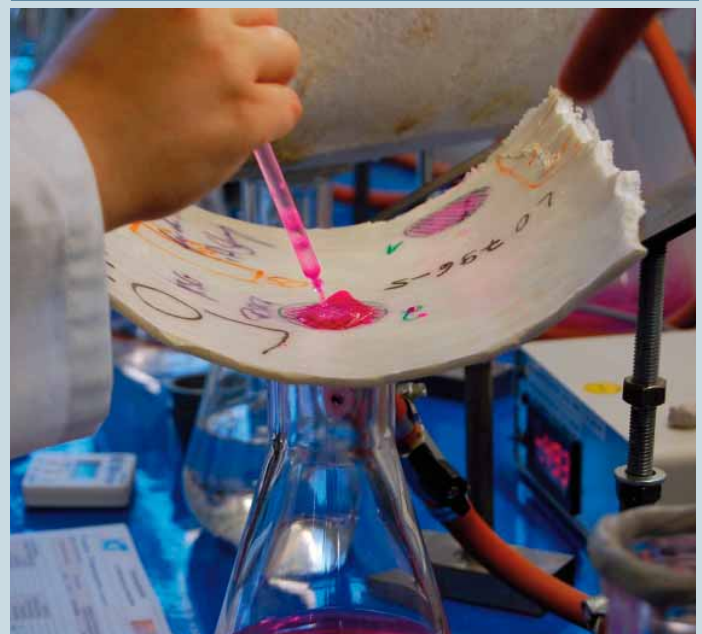
Tightness testing: water containing a red dye is applied to the inner side of the liner

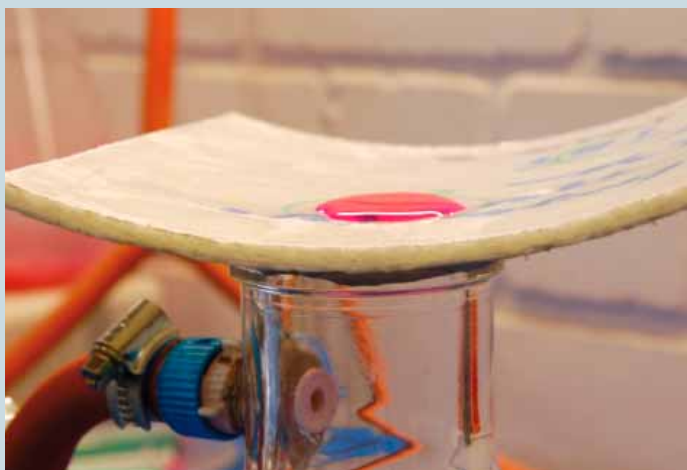
Tightness testing: liner tight

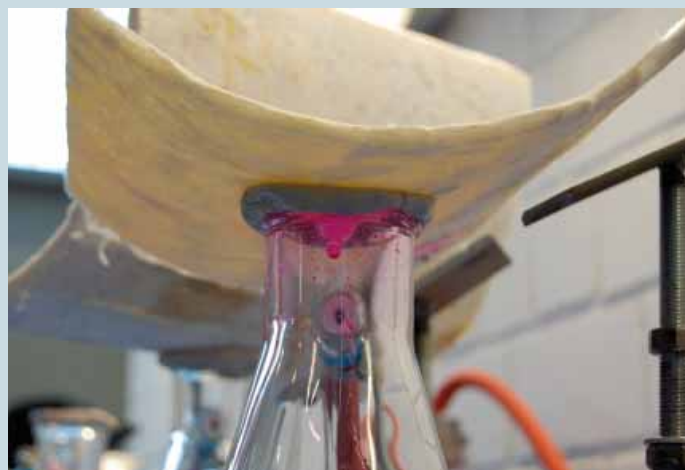
Tightness testing: liner not tight
