## IKT-LinerReport 2008

# Tube liner quality: Variegated trend

Tube liners improved on a broad front in 2007, whereas 2008 has brought both advances and retreats. Where are the potentials for improvement in individual liner systems?

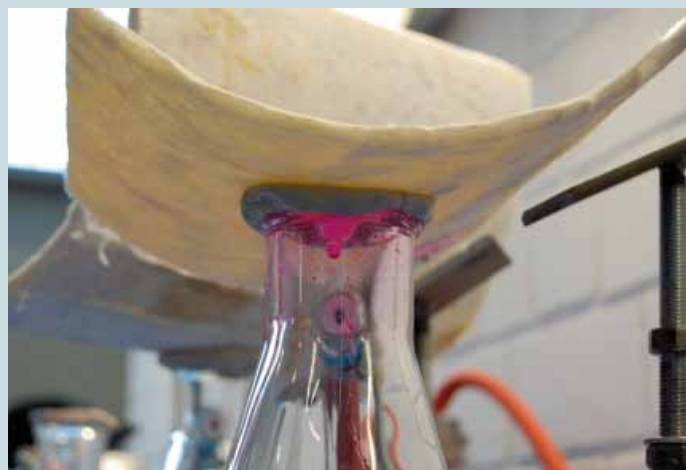
Tightness testing: liner not tight
